# Multi-Variate Study of Stormwater BMPs

2008 Green Building Research Fund Grants | FINAL REPORT | March 2011

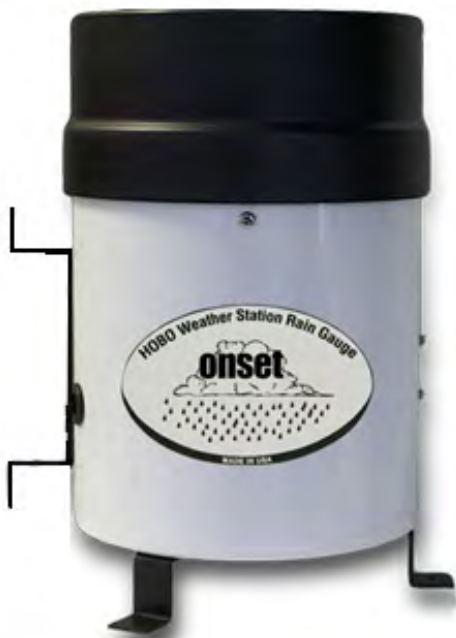
Figure 1.1 HOB0 Data Logging Rain Gauge Data Logger

Each site integrates an Onset Data Logging Rain Gauge that measures rainfall quantity and intensity. We are using the HOB0® Data Logging Rain Gauge Data Logger, Model: RG3. This model is battery powered and integrates a tipping-bucket rain gauge that automatically records rainfall data, rates, times, and duration. (A time and date stamp is stored for each tip of the rain gauge bucket).

Installation Requirements: It was important that the gauges be located near the BMP sites in a level and elevated mounting position with minimal opportunity for interference from tall objects and wind disturbance.

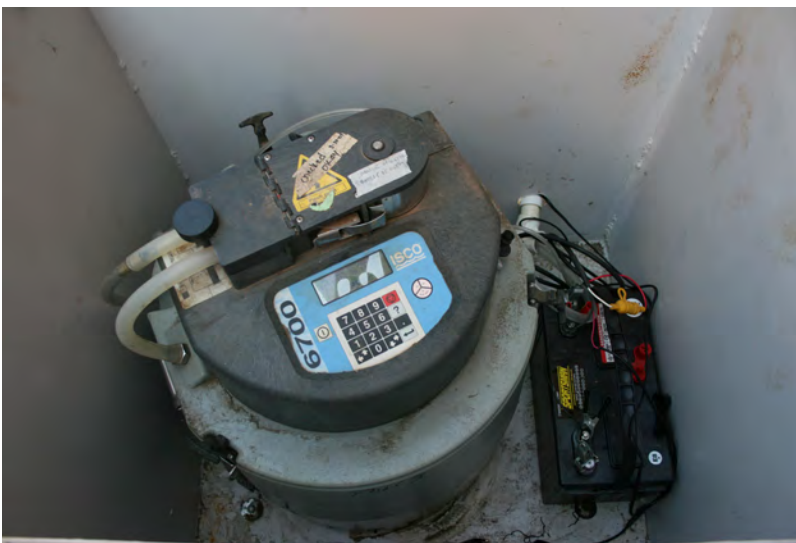
Figure 1.2 ISCO Portable Sampler

All monitoring locations included either a Teledyne ISCO 6700 or 6712 Portable Samplers (Teledyne ISCO, INC., Lincoln, NE) with a Teledyne ISCO 730 Bubbler Flow Module attached. Where site conditions allowed, the ISCO samplers were installed in BMP inflow and outflow pipes. This allowed us to compare water quantity measurements up and down stream of BMPs.

The bubbler flow modules use an internal air compressor to force a metered amount of air through a bubble line submerged in the flow channel. By measuring the pressure needed to force air bubbles out of the line, the water level can be calculated. The ISCO Sampler then calculates flow rate from the water levels. It is suitable for small channels and is not affected by wind, steam, foam, or turbulence.

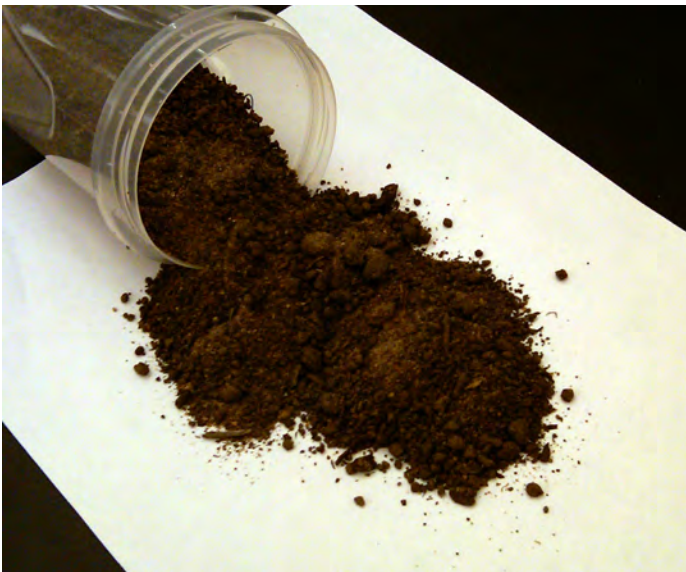
Figure 1.5 Soil Sample

Soil sampling was done to test particle size distribution, pH, Zinc, bulk density, and organic matter content of the planting soil within the BMPs. These characteristics provide an indication of soil quality and compaction for the plant growing environment with correlations to water infiltration rates. As BMPs mature, the ratios of these parameters should change due to plant growth and root penetration, mulch decomposition, microorganism activity, plus the influx of sediment and pollutants to the BMPs.

ASTM F1631 Method B was used to complete the Particle Size Evaluation, and ASTM F1647 Method A was used to calculate Organic Matter.

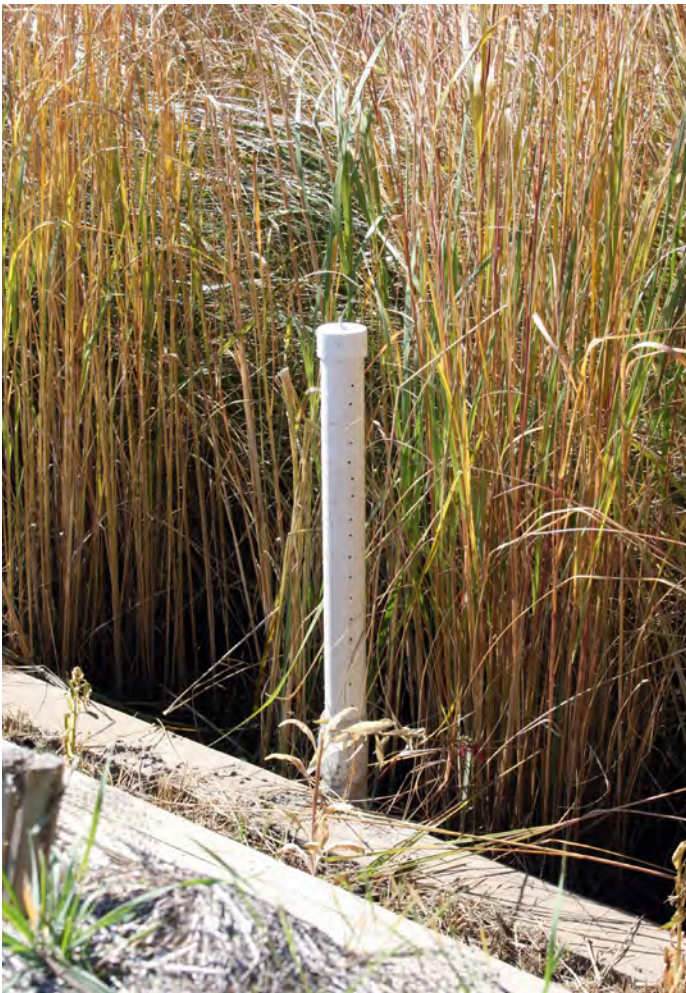
Figure 1.6 Piezometer

Piezometers (small diameter wells) were installed at the City Union Mission site to help measure how well the Infiltration basins function during storm events, infiltrate water into the surrounding subsoil, and recover capacity between storm events. The wells allow for the measurement of water levels within the infiltration basins. In addition, the wells measure the time between the start of a rain event and when the storage volume exceeds capacity and overflows.

The wells consist of perforated PVC pipe that was installed in shallow auger holes advanced into the raingarden beds. The wells were installed three feet into the soil (to match the depth of engineered soil). A pressure transducer was suspended near the bottom of the each well. Pressure head readings were recorded by the transducer and converted to water level readings.

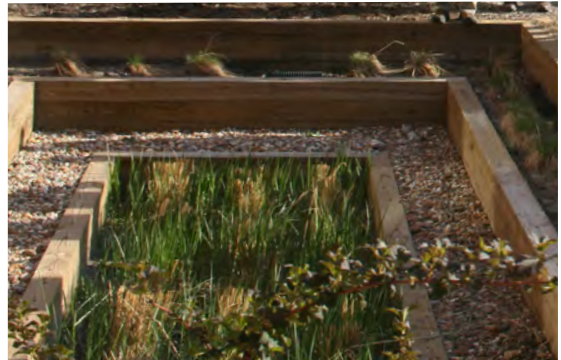
Figure 2.4 Basin #1

A series of three interconnected vegetated infiltration basins collect roof and site runoff (Figure 2.6). Each basin consists of a shallow depression framed with wooden timbers. The basins were backfilled with permeable engineered soils and planted with grasses and flowers. Basin #1, as shown in Figure 2.4, is the first cell in the series, and is monitored for runoff quality and quantity. This cell receives about half of the roof runoff (Figure 2.7). Runoff from three roof drains enter the infiltration basin through a perforated pipe that wraps the basin and acts as a level spreader. The outlet from Basin #1 is a slotted area drain that conveys water to the second infiltration basin. The outlet from Basin #2 conveys water to Basin #3 (Figure 2.7). This system costs very little to construct and was easy to install, which makes it a very useful example of BMP design and implementation.

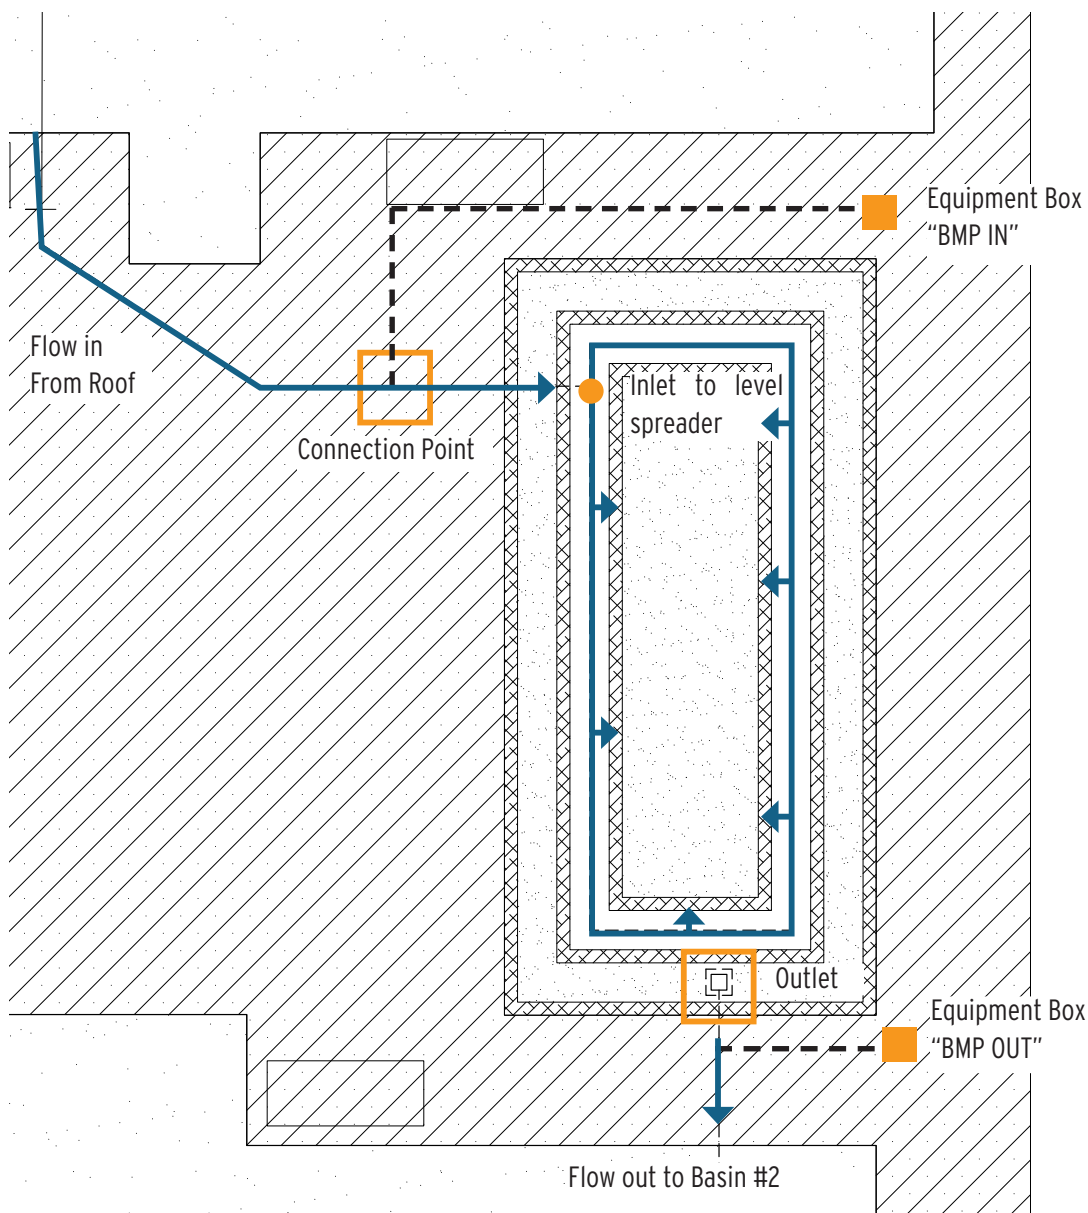
Figure 2.8 Basin #1 Monitoring Equipment

Two ISCO samplers were installed at this site, one at the inflow and one at the outflow point of Basin #1 (Figure 2.8). This configuration allowed the research team to compare water quality and quantity of water entering the infiltration to water exiting the basin. The connection point shown in Figure 2.8 is where the 1/2" ISCO sampler tube connects to the inlet or pipe to sample water. The connection point is illustrated in more detail in the Basin Section illustrated by Figure 2.9. In addition, water level monitoring wells were installed in Basins 1 and 3 to help assess infiltration rates in the basins.

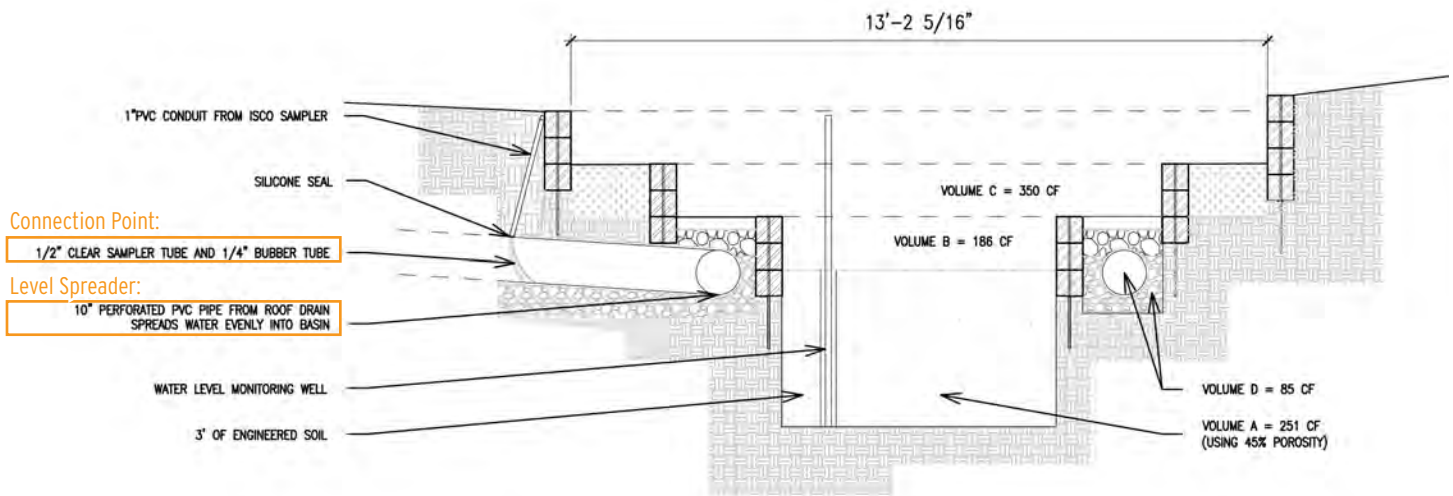
Figure 2.9 Basin Section

Figure 2.9 shows the inlet pipe into the level spreader. Runoff is distributed via a level spreader that distributes runoff equally around all sides of the basin. The two lower levels plus the three feet of engineered soils in Basin #1 hold approximately 872 CF of runoff. The water level monitoring well documented how water moved through the basin during and after each rain event.

Based on the design, the infiltration basin holds a 2.3 inch rain if totally full.

$$\frac{872 \text{ CF}}{7,000 \text{ SF Roof Area}} = 0.12 \text{ ft or } 1.44 \text{ inch Rain Event}$$

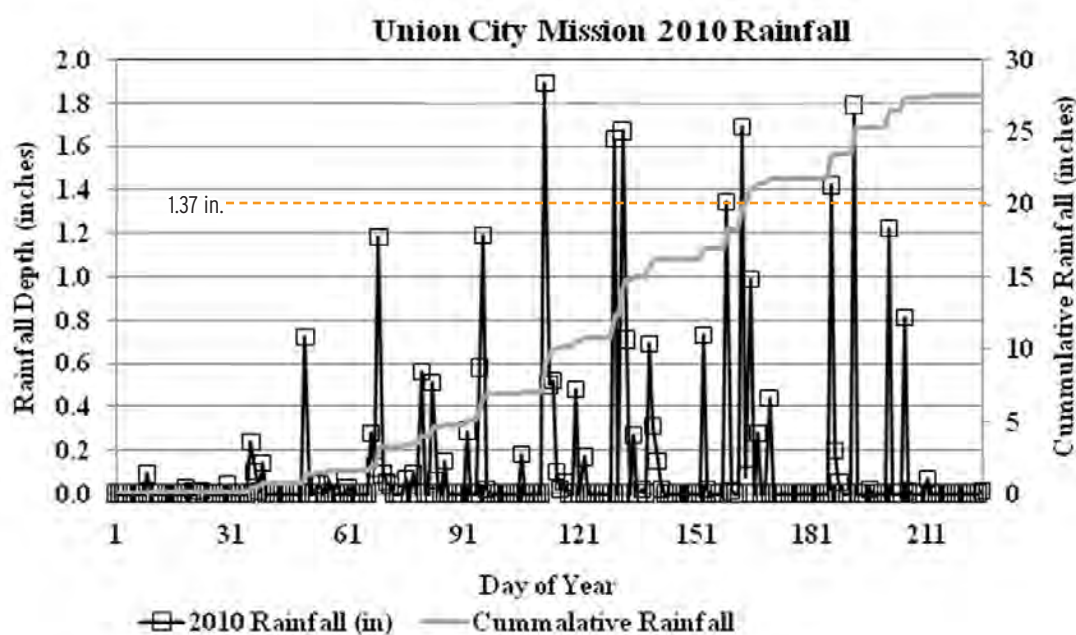
Figure 2.13 Precipitation Summary (2010)

In 2010, we had seven rain events larger than the water quality storm event (1.37 inches). The largest rain event was on 4/22 (day 112) at 1.89 inches. This followed a 15-day period without much precipitation. On 5/10, 5/12 and 5/13 (days 130-133), we received the most precipitation in a short period of time in 2010 (1.63, 1.67, and 0.71 inches respectively). This followed 9 days without much precipitation.

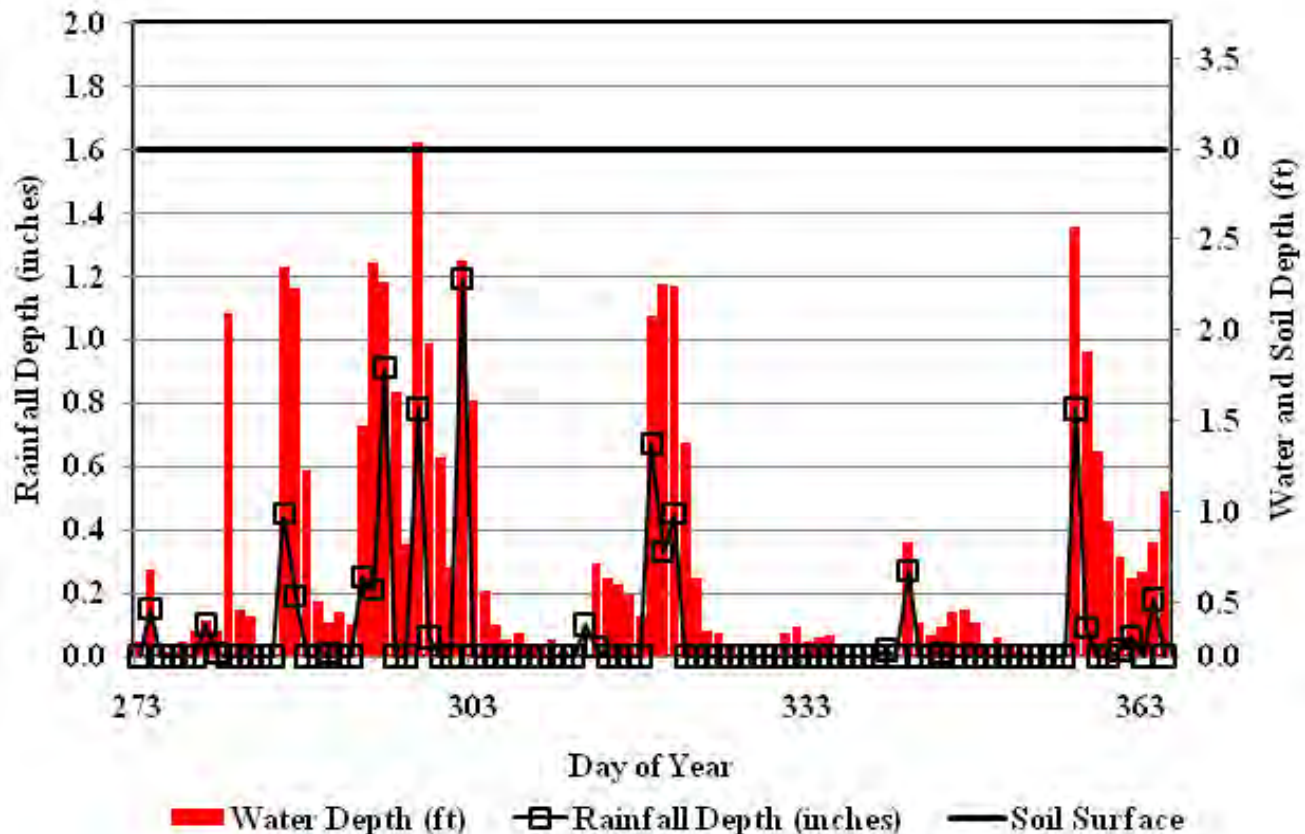
Figure 2.14 Basin #1 Rainfall, Soil and Water Depth Results (Fall 2009)

Piezometers were added on September 29, 2009 (day 273) to the first and third infiltration basins (second half of the first monitoring year). Piezometers measure water level related to time. Figure 2.14 shows that the water level of Basin #1 was almost always eight inches or more from the soil surface. The water level reached the soil surface one time within the 90-day monitoring period in late 2009. This indicates that Basin #1 is effectively infiltrating and storing water.

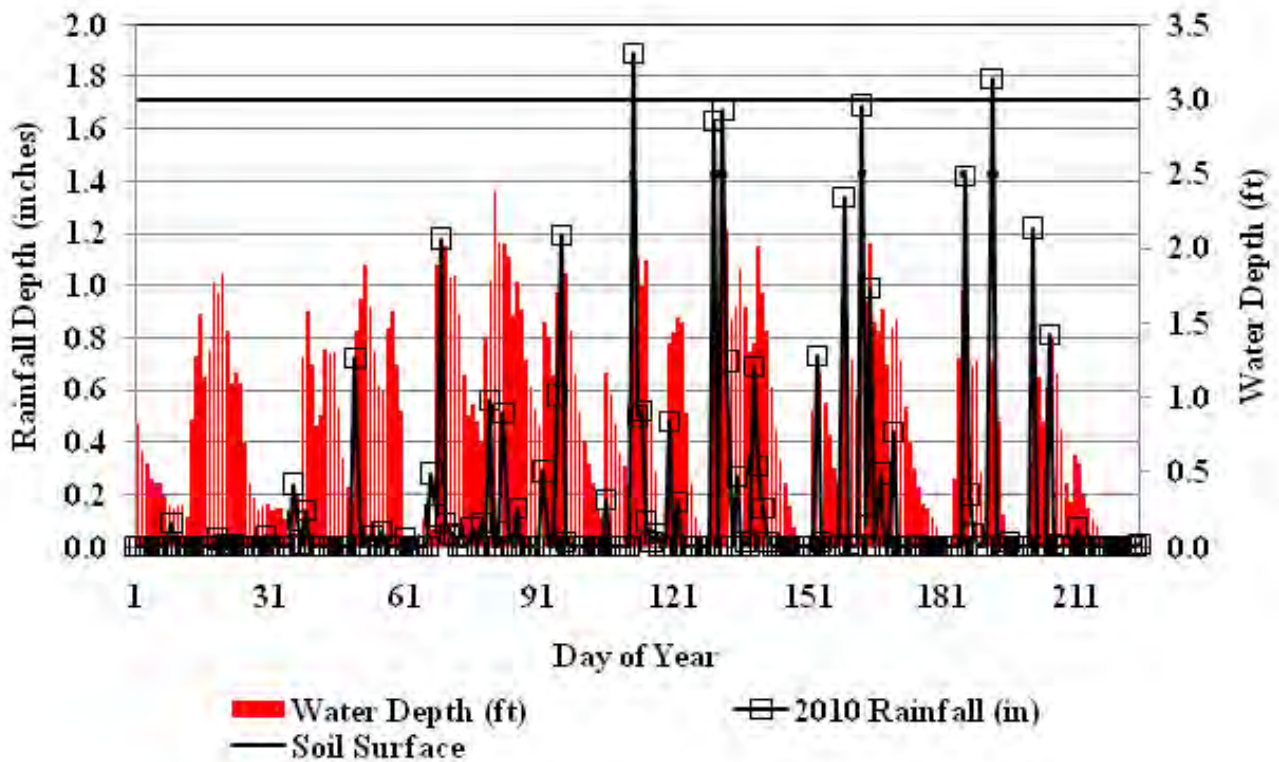
Figure 2.15 Basin #1 Soil and Water Depth Results (2010)

Figure 2.15 shows the elevation of water within Basin #1 (shown in red). Water Depth 3.0 feet represents the top elevation of the engineered soils or bottom of the basin. (The engineered soils were installed at three feet deep). According to the data, the basin did not have standing water in 2010. This is consistent with observations made by the building staff. In addition, the infiltration rate was estimated by how fast the red lines trend down from the peaks. In general, the basin was draining in 2010 at an average rate of .06 inches per hour (1.4 in. / day).

This estimated infiltration rate is consistent with what might normally be expected in soils with a high silt and clay content, such as were found beneath the infiltration basins. However, site observations suggest that water infiltrated much faster than

this rate. For example, as shown in Figure 2.15, water levels only extended above the soil surface during two storm events in 2010. This data indicates that the basin can sufficiently infiltrate and store water. Water is believed to be seeping laterally out of Basin #1 through permeable fill material at the site. The low infiltration rates may be representative of deeper native soils, but lateral infiltration through fill material may be occurring at higher water levels.

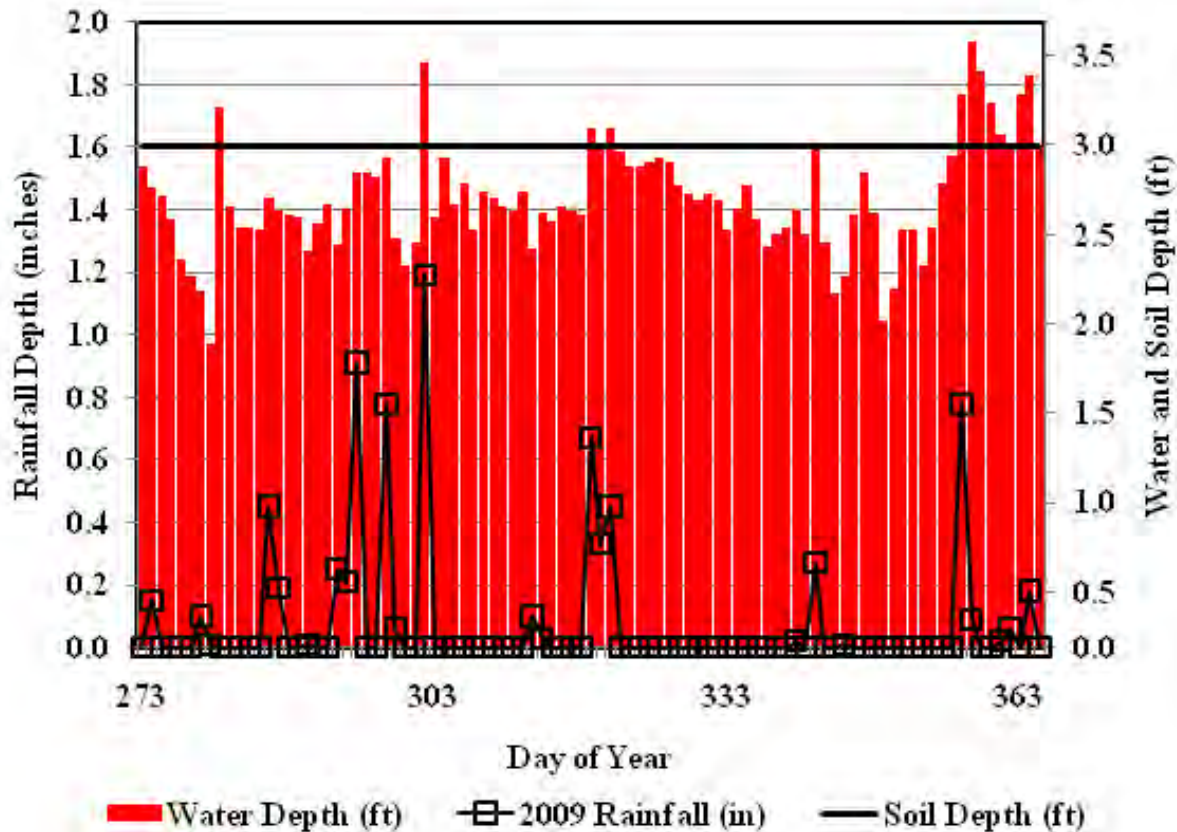
Figure 2.16 Basin #3 Rainfall, Soil and Water Depth Results (Fall 2009)

Figure 2.16 shows the elevation of water within Basin #3. The infiltration rate of Basin #3 in 2009 averaged 0.044 inches per hour (1.1 in/day). The infiltration rate in Basin #3 is slower than Basin #1. This estimated infiltration rate is consistent with expected rates for clayey soils and is likely representative of the deeper underlying soils. Site observations do suggest higher infiltration rates, given the limited number of outflow events from the basin. It is believed that at higher water levels water seeps laterally out of the basin, through the timber walls. The basin is placed in an exposed location adjacent to a sunny, southwest facing embankment. This may promote lateral exfiltration and evaporation of collected water into drier surrounding soils.

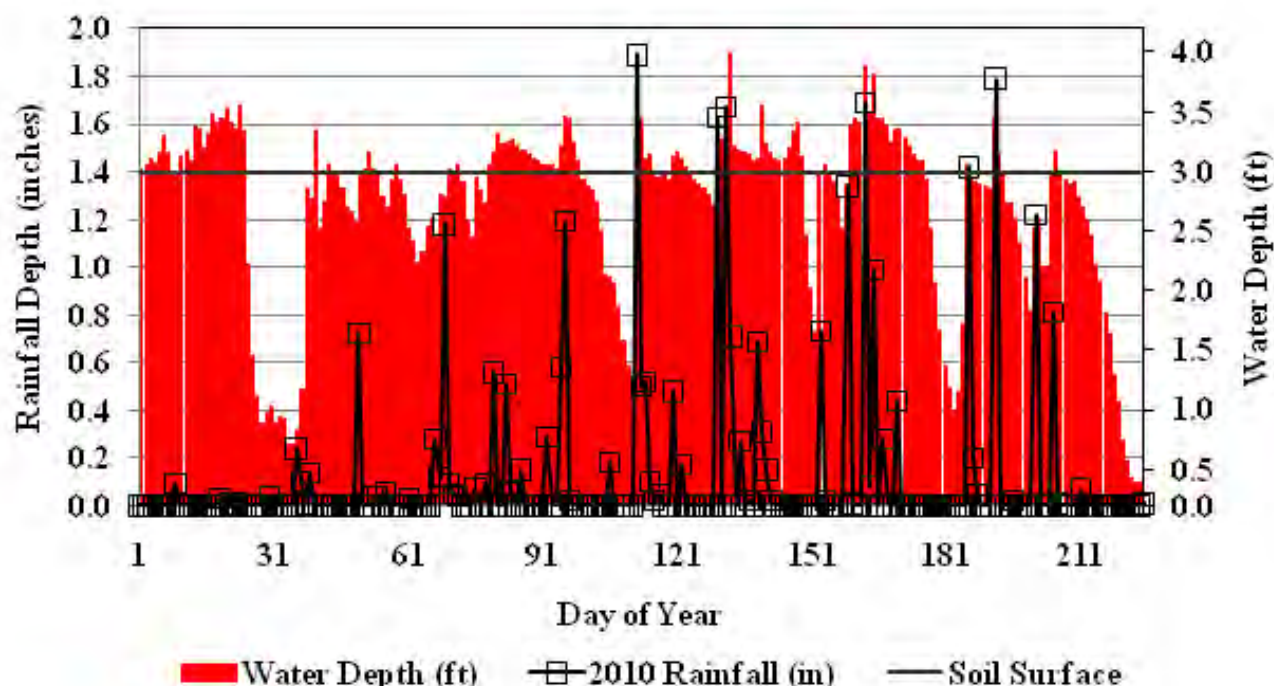
Figure 2.17 Basin #3 Soil and Water Depth Results (2010)

Figure 2.17 shows the elevation of water within Basin #3. The water elevation in 2010 trended near the top elevation of the engineered soils or bottom of basin with standing water regularly observed after rain events. This is consistent with observations made by the building staff. The infiltration rate in 2010 averaged 0.08 inches per hour (slightly higher than in 2009).

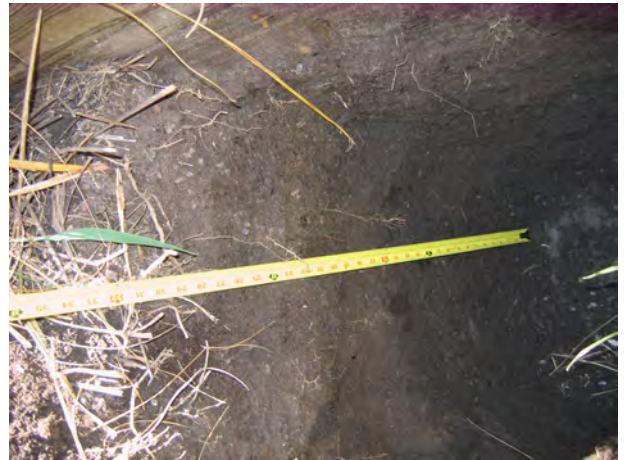
Figure 2.18 Prairie Cordgrass Root System

As documented in Figure 2.18, the Prairie Cordgrass root system reached 30 inches deep after three growing seasons within Basin #1 (6 inches above the bottom of the basin engineered soils). The root growth within Basin #3 was slower, which could be associated with available water. Since basin #1 was drier with less periods of standing water, the root growth was more prolific. In addition, the infiltration rates were higher. As the roots grow in basin #3, the infiltration rate is expected to improve.

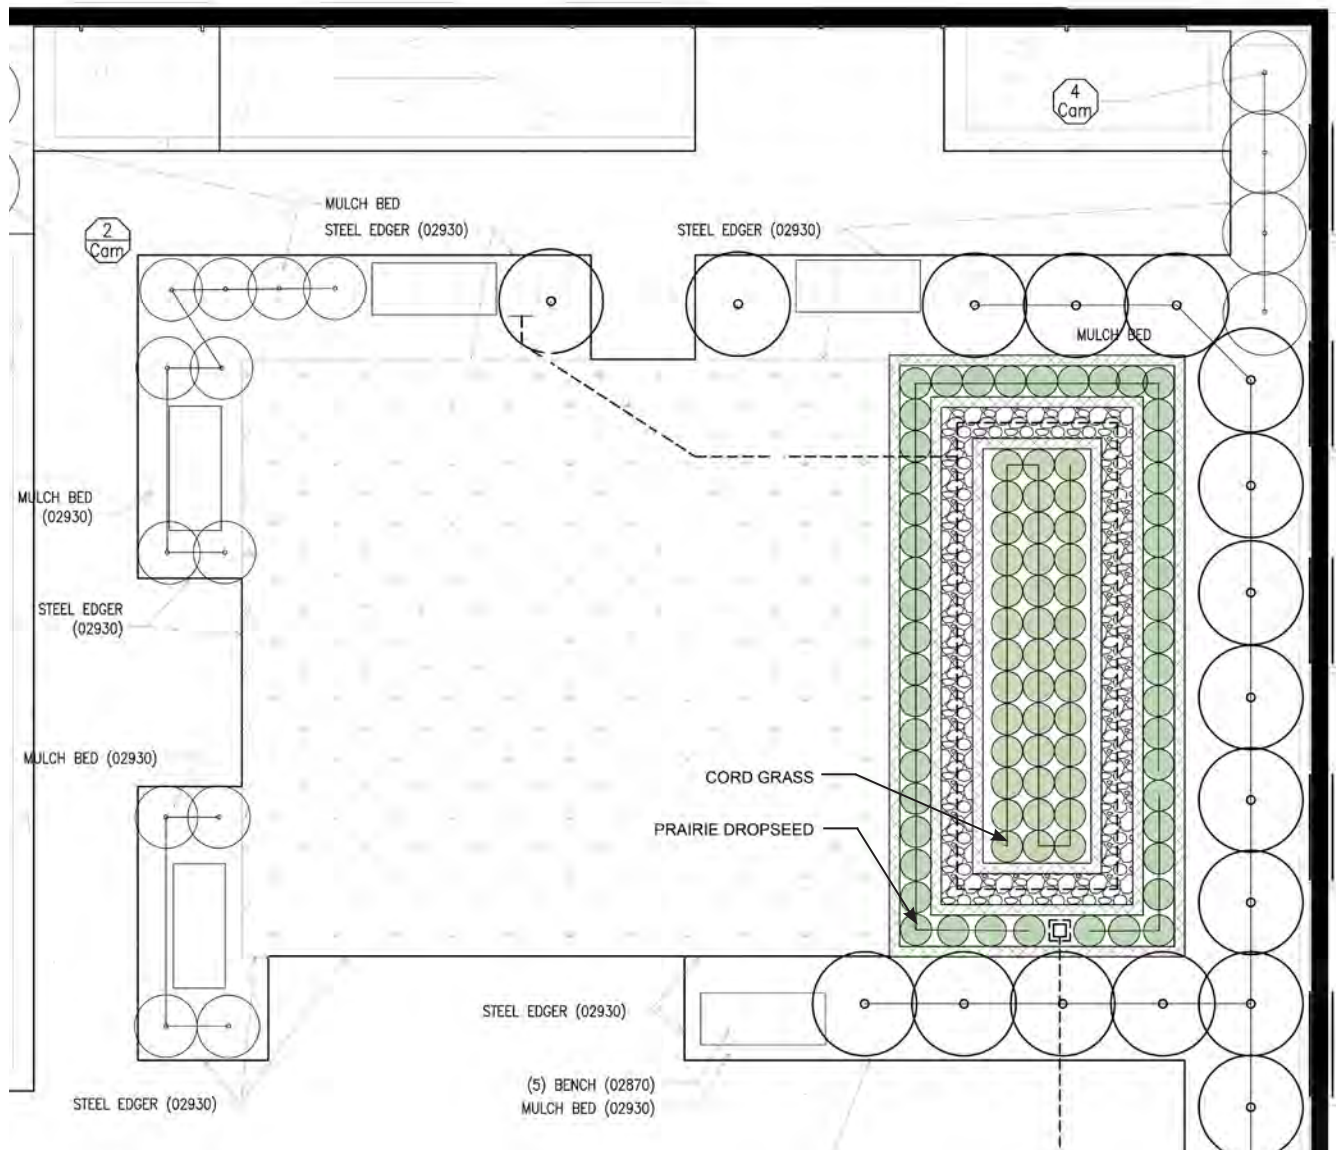
Figure 2.20 Planting Plan

Vegetation was selected for its ability to withstand wet weather, drought, and short periods of ponding. The basins were planted with a simple plant palette of *Spartina pectinata* (prairie cordgrass), *Sporobolus heterolepis* (prairie dropseed), and *Lobelia cardinalis* (cardinal flower). Prairie Cordgrass was planted in the lower section of the basin. Its tolerance of wet conditions made it a suitable plant for the basin bottom. Prairie Dropseed was planted on higher elevations because of its preferred drier conditions (Figure 2.20).

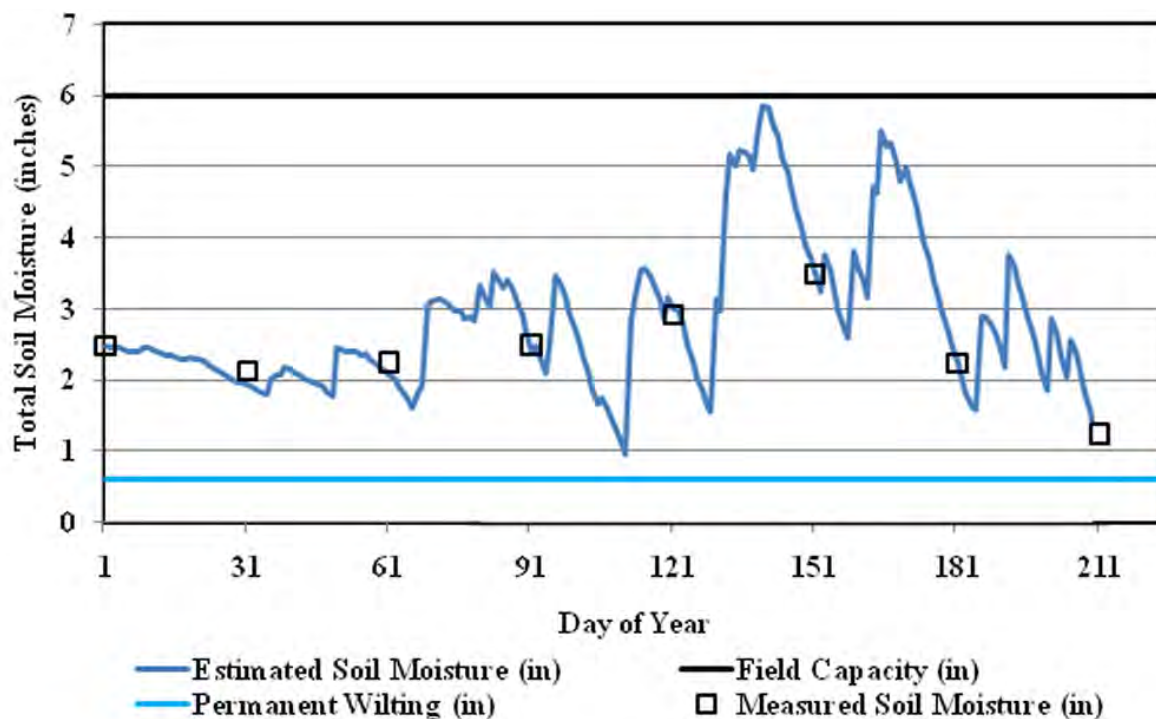
Figure 2.21 Basin #1 Soil Moisture (2010)

Figure 2.21 shows the soil moisture within Basin #1. Eight soil cores were taken over the course of 2010. Samples were collected every 12 inches for the full 3 feet of engineered soil. A composite soil moisture test was conducted (as shown by the black boxes). The black horizontal line (shown at 6 inches) represents soil moisture at 1/3 bar (not quite full saturation). The blue line represents the results from the Modified Penman Equation. This equation estimates the amount of water available for grasses. The equation takes into account temperature, humidity, wind speed, rainfall, and solar radiation (components of evapotranspiration). As the blue line nears the 1/3 bar (shown as the thickened line at 6 inches), the basin is considered saturated, and runoff is expected.

- In 2010 we could have anticipated about 2 periods of standing water within the basin (shortly after rain events on 5/12 and 6/12). According to the monitoring well data, this did not occur, nor were any outflows from Basin #1 observed. This is likely due to lateral filtration of water to fill material around the basin.
- The moisture levels were consistent throughout the year. In general, the soil held moisture nicely providing a good growing environment. Conditions were seldom near the wilting point nor overly saturated.

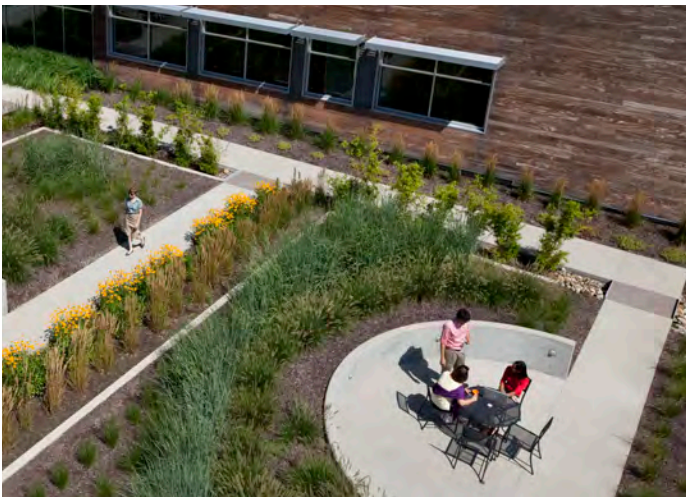
Figure 3.1 Courtyard to be Monitored

Monitoring Concerns: 1) The courtyard is typically irrigated. 2) There are four roof downspouts, and thus, we will not be able to measure inflow hydrographs at all inlet flows (due to limited equipment); however, we should be able to calculate total runoff volumes from the roof drainage area. 3) The raingarden design acts like a bioswale with little holding capacity, but the design encourages substantial infiltration and evapo-transpiration opportunities.

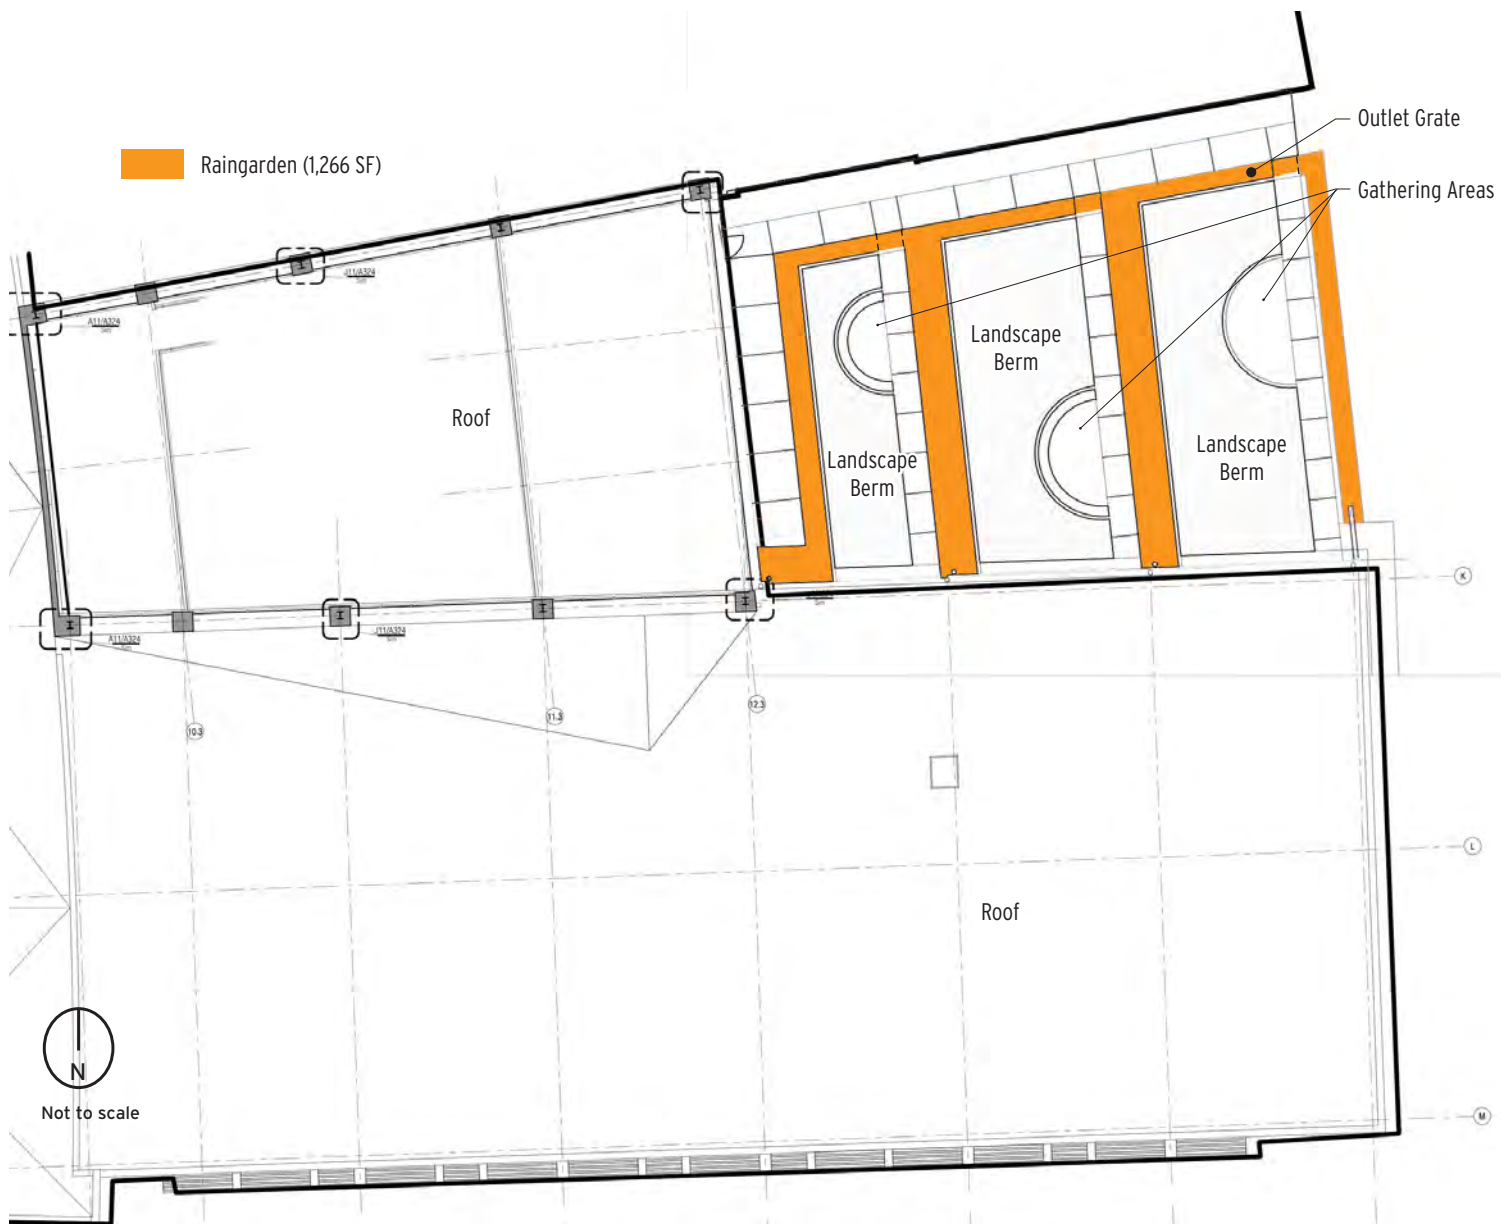
Figure 3.4 Raingarden Layout

The third (southern) courtyard was selected for stormwater monitoring. Figure 3.4 illustrates the layout of the raingardens in relationship to the courtyard design. Roof runoff from four downspouts runs through a series of interconnected linear raingardens across the courtyard to the north and then east toward the outlet grate. The courtyard provides three intimate gathering areas for outdoor meetings, each separated by a berm with native ornamental grasses. The raingardens are an integral component of the courtyard landscaping, and they serve an important role in cleaning the runoff before it is directed to the storm sewer system.

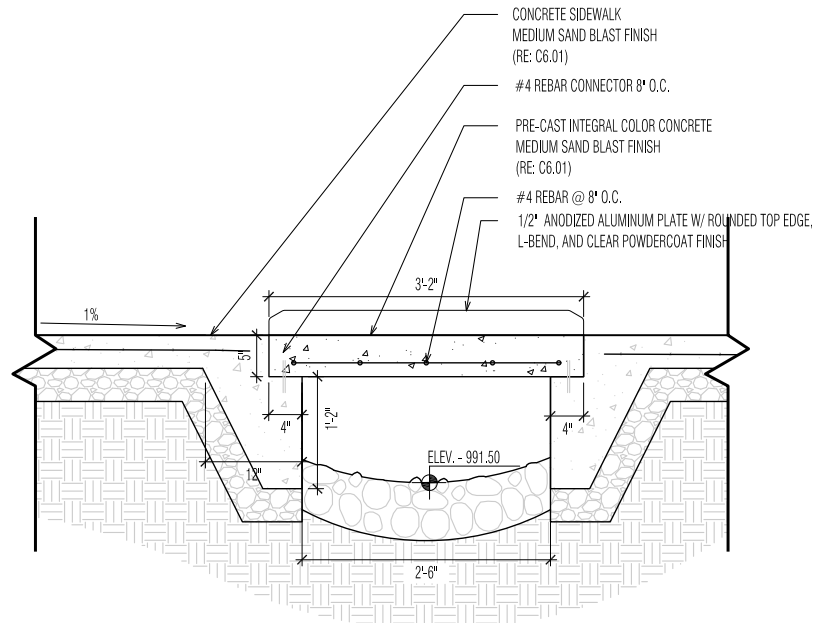
Figure 3.6 Sidewalk Span Over Raingarden Section

This site drainage within the courtyard demonstrates cost-effective site design approaches. For example, there are no underdrains or engineered soils. Figure 3.7 illustrates a typical section of the sidewalk adjacent to the depressed raingarden and the landscape berm. The raingarden is planted with a mix of native Kansas plants and cultivars in 8-inches of planting soil mix. The linear raingardens are graded to let water flow without using underdrains. Figure 3.6 shows one instance of how the raingarden allows water flow under the sidewalk.

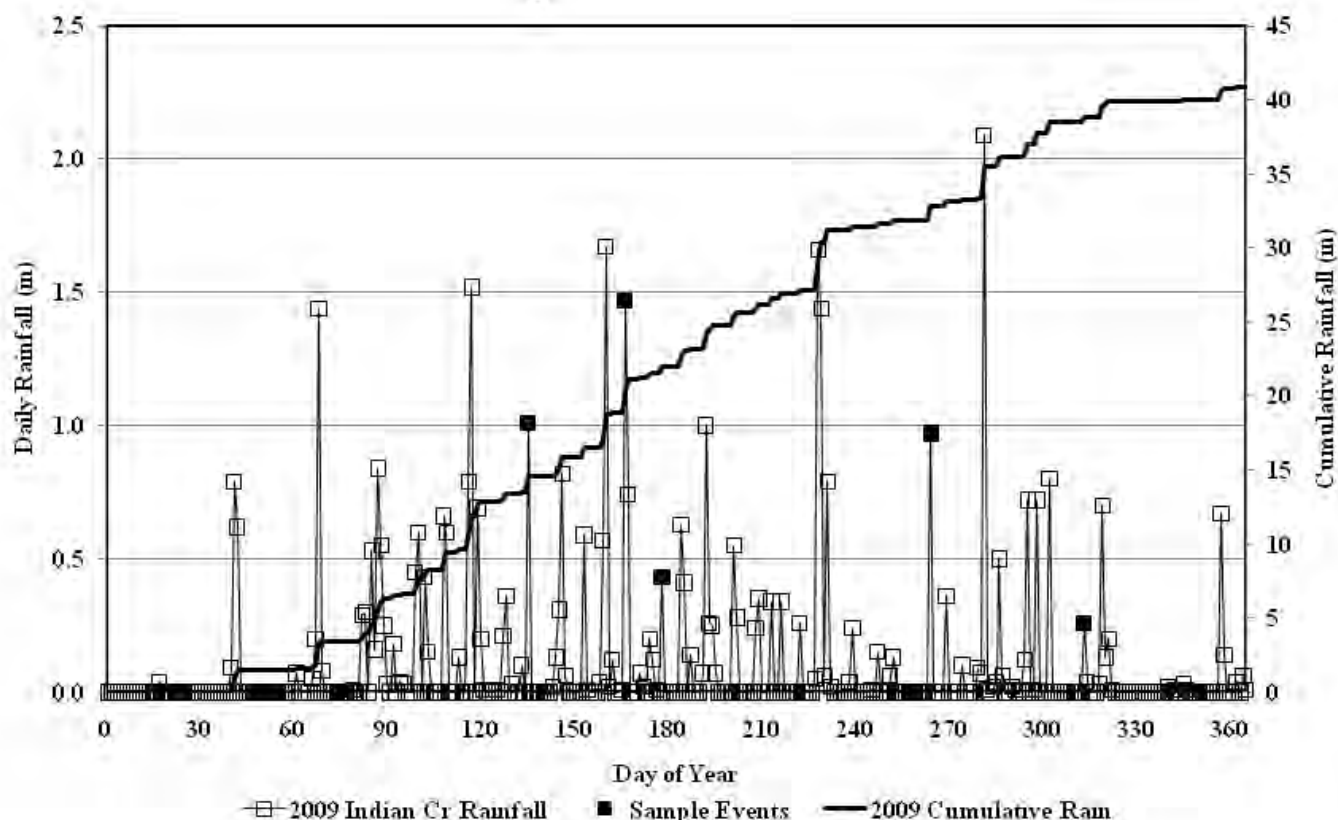
Figure 3.8 Precipitation Summary (2009)

The above figure shows the local precipitation and on-site monitoring data for 2009 sampled events. The equipment was installed on May 14th (Day 134). In 2009 we had 5 rain events larger than the water quality storm event (1.37-inches or 90% of the average annual stormwater volume of all 24-hour storms). We were able to capture 5 rain events following a variety of different storm sizes. The cumulative rainfall recorded at the Applebee's site is also shown.

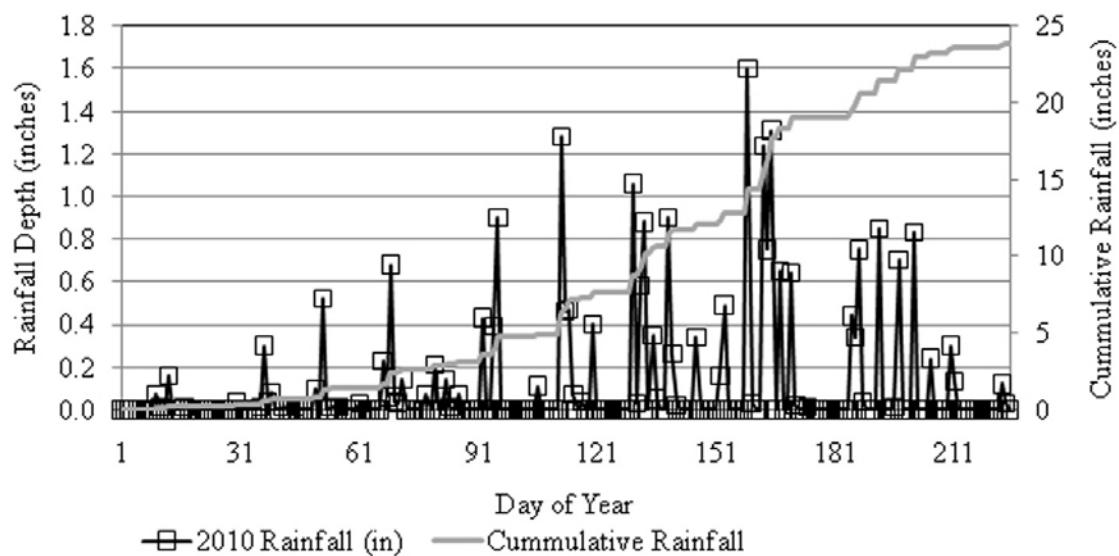
Figure 3.9 Precipitation Summary (2010)

In 2010 we had 1 rain event larger than the water quality storm event. Of the 12 rain events sampled, nine occasions of discharge were recorded from the courtyard. Field observations indicate a tenth discharge also occurred on 4/6. (Mulch was removed from the outlet grate referencing flow.) Based on this data, it was identified that a rain event larger than a 1/3-inch rain event was needed for an outflow to occur.

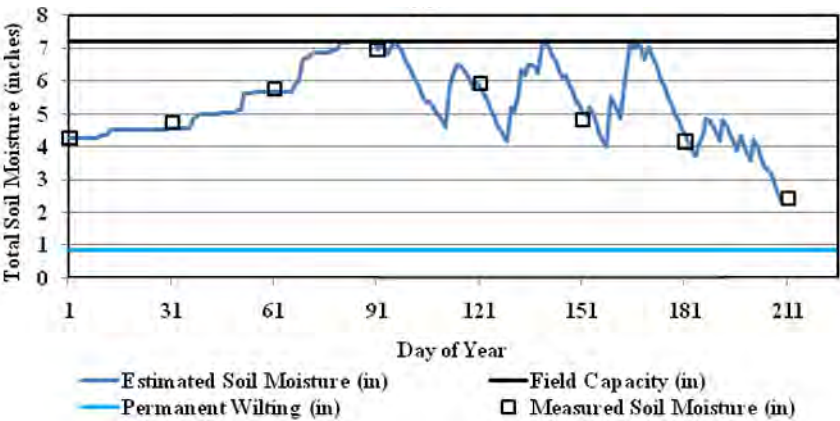
Figure 3.15 Soil Moisture Summary (2010)

The following figure shows the soil moisture within the raingarden. A soil core was taken during 2010 on 8 occasions. A soil moisture test was conducted from the top 12 inches of soil (as shown by the black boxes). The black horizontal line (shown around 7.25 inches) represents soil moisture at 1/3 bar (not quite full saturation). The blue line represents the results from the Modified Penman Equation. This equations estimates the amount of water available for grasses. The equation takes into account temperature, humidity, wind speed, rainfall, and solar radiation (components of evapotranspiration). As the blue line nears 1/3 bar, the basin is considered saturated, and runoff is expected. Shown below runoff was expected to occur during six periods throughout the summer of 2010.

As indicated, the soil moisture within the raingardens was consistent throughout the year, providing a good environment for plant growth. The irrigation system was de-activated during the 2010 testing period, and the soils maintained moisture levels never drying out. The soils were traditional planting soils with a combination of topsoil and compost. No sand or aggregates were added.

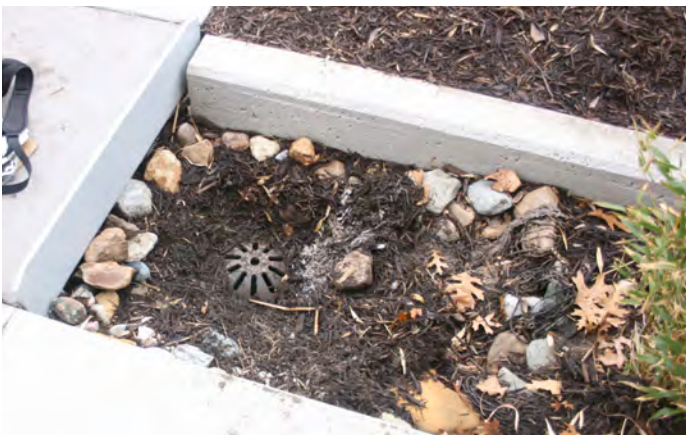
Figure 3.17 Original Designed Outlet Drain

- Create near flat slopes to promote infiltration and absorption by plants.
- Evaluate the elevation of the outlet structure, taking into account mulch and debris buildup. During the first year of establishment, erosion was occurring at the eastern edge of the raingarden. It was observed that the outlet was covered with mulch and set too low (Figure 3.17). The outlet structure was raised with a perforated riser to resist clogging and provide better drainage during larger rain events (Figure 3.3).
- Consider irrigating new raingarden installations with permanent or temporary systems until plants are established.
- Consider check dams to add storage capacity to raingardens.

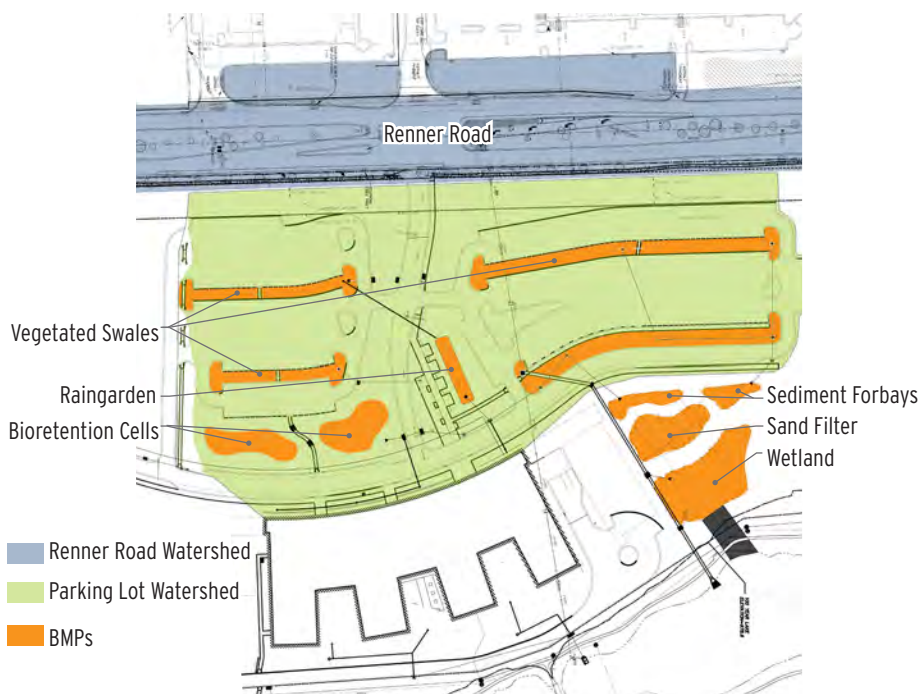
Figure 4.4 Watershed and BMP Layout Diagram

At the Applebee's site, a series of BMPs occur in sequence, providing a multi-BMP "treatment train." At this location, there are two watersheds being monitoring and compared (Figure 4.4). The Renner Road Watershed is 5.2 acres of public street right-of-way. Runoff from this watershed is sampled before it is treated by any type of BMP. The Parking Lot Watershed is 13 acres of internal drive/parking areas. Runoff from this watershed is sampled before it enters on of the sediment forebays.

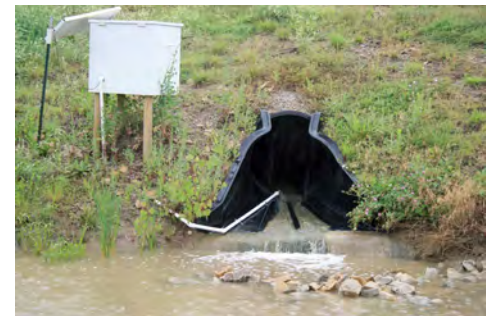
Figure 4.7 Entry pipe to Sediment Forbay (from parking lots) Runoff appears to be carrying sediment from upstream BMPs and landscape construction project.
