# Multi-Variate Study of Stormwater BMPs

2008 Green Building Research Fund Grants | FINAL REPORT | March 2011

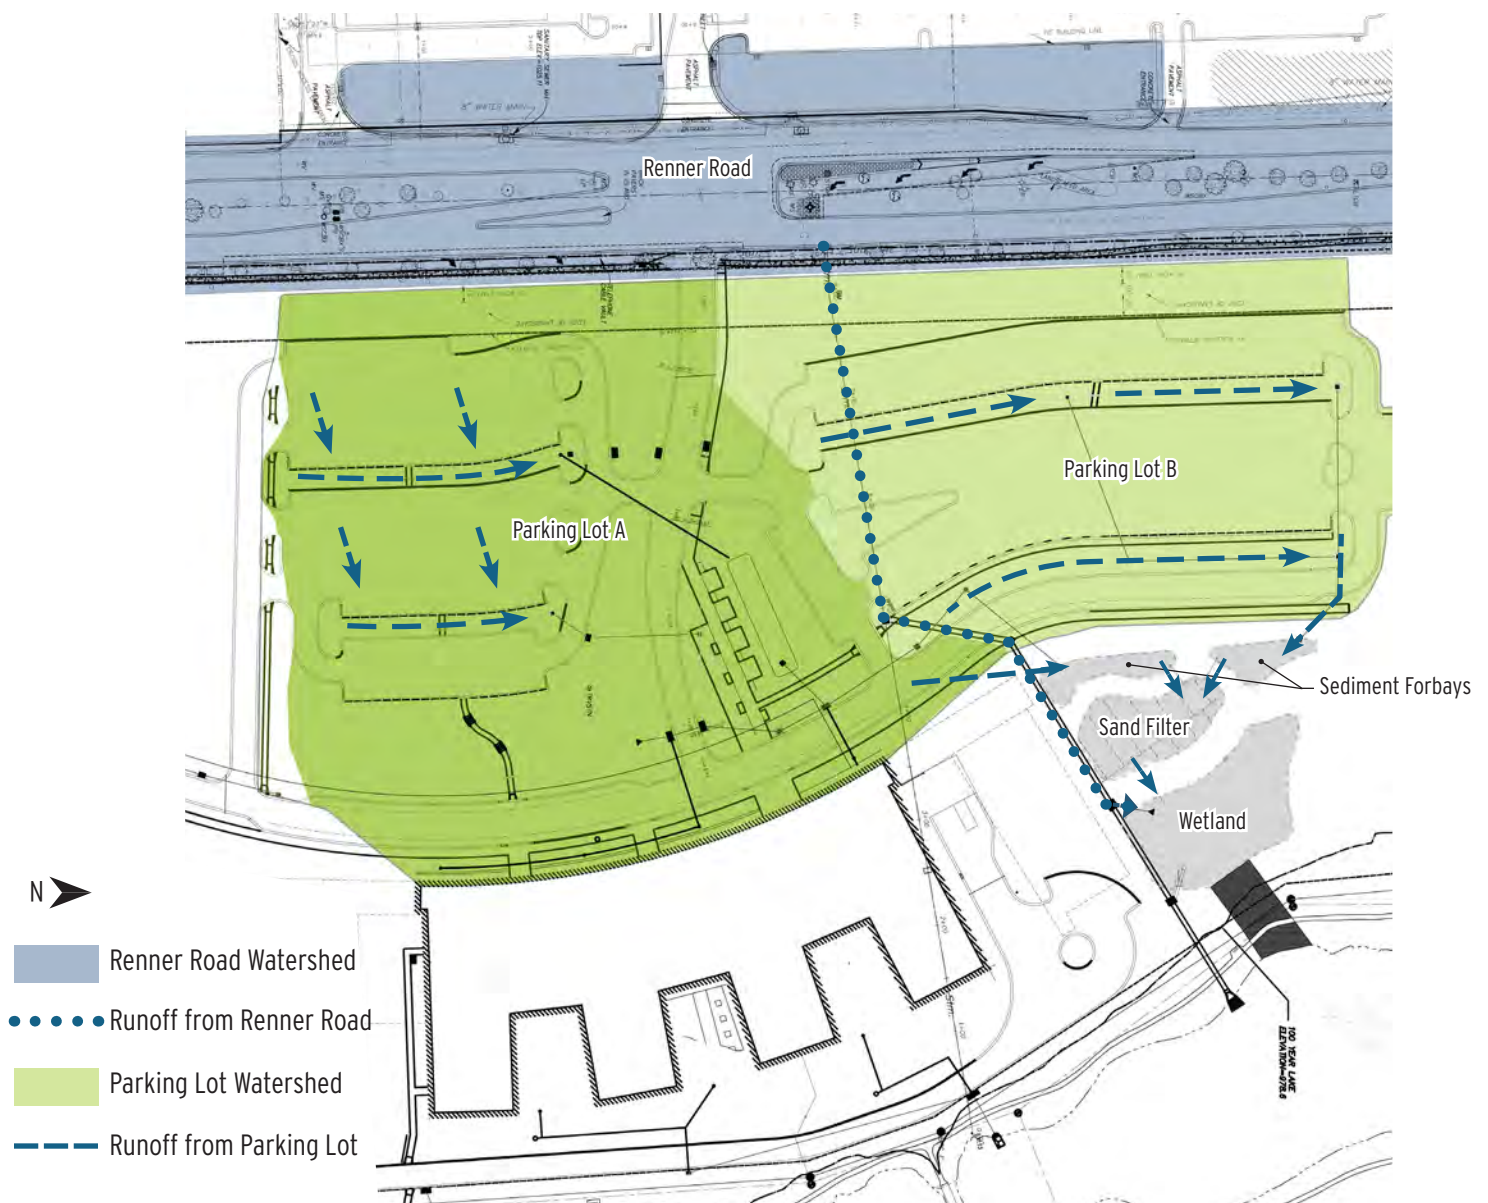
Figure 4.10 Water Flow Diagram

As diagramed in Figure 4.10, the runoff from Renner Road Watershed is piped under the parking lot to a monitoring station, which samples the water before it is released to the wetland. The Runoff from the Parking Lot Watershed flows through a series of BMPs before it is sampled. Within the Parking Lot Watershed, the terraced 610 parking stalls are separated by broad vegetated swales located in landscape islands that treat the stormwater runoff where it falls by directly intercepting it from the paved surfaces. Once intercepted, the runoff flows perpendicular to the slope of the parking lot through turf vegetated swales. The mild

slopes and vegetation in the swales slow the time of concentration, allowing the Blue Flag Iris, Switchgrass, and other native plantings more time to absorb the runoff and maximizing the contact time of the runoff with the soil before being intercepted by area inlets. From the inlets, the stormwater is discharged into two separate sediment forebays feeding a surface sand filter for additional cleansing. The sand filter is located upstream of a nearly one-half-acre constructed wetland flanking the north side of the building.

The wetland was sized to treat the stormwater runoff volume of a 2-year (50%) storm event from the 5.2 acres of off-site public street right-of-way and commercial development, in addition to the runoff from the Applebee's parking lot (Figure 4.10). A 42-inch storm sewer line from Renner Road connects to a junction manhole near the wetland. Within the manhole is a 2-foot tall divider wall that sends water toward the wetland during smaller rain events (up to the 2-year event). Flows are conveyed to the wetland via a 12-inch concrete pipe.

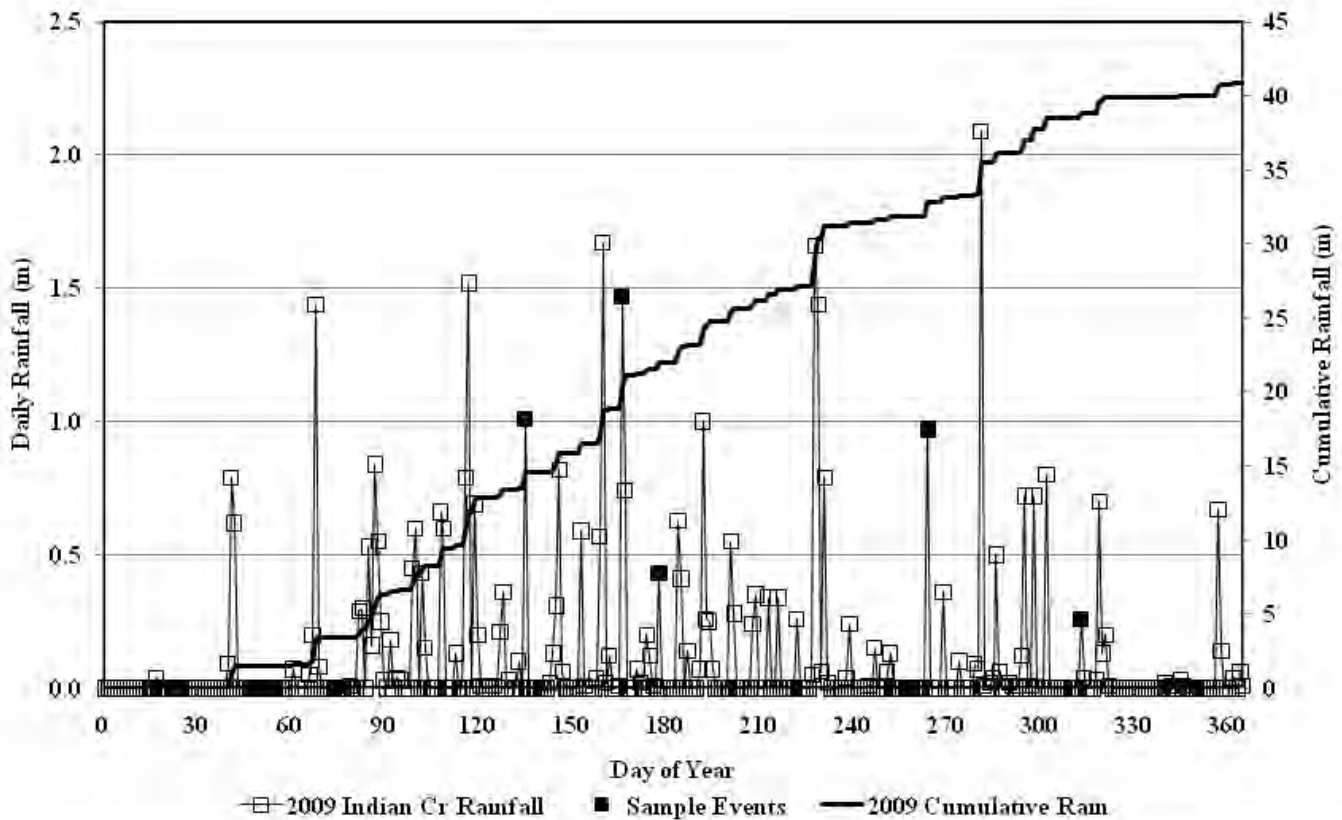
Figure 4.12 Precipitation Summary (2009)

The above figure shows the regional precipitation (outlined squares) and on-site monitoring data (black squares) for 2009 sampled events. The equipment was installed on May 14th (Day 134). In 2009 we had 5 rain events larger than the water quality storm event (1.37-inches or 90% of the average annual stormwater volume of all 24-hour storms). We were able to capture 5 rain events following a variety of different storm sizes. The cumulative rainfall recorded near the Applebee's site is also shown.

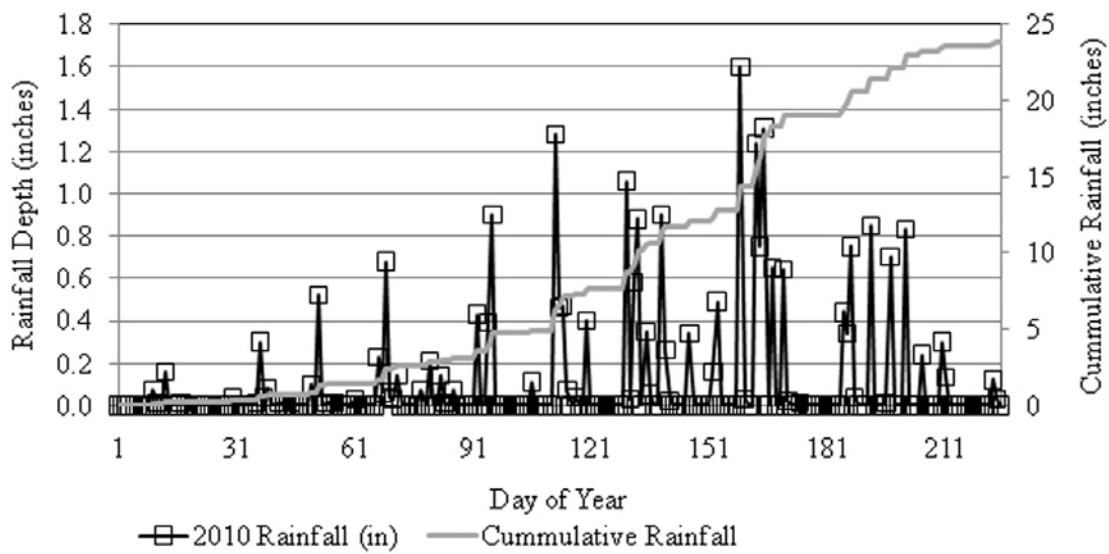
Figure 4.13 Precipitation Summary (2010)

In 2010 we had one rain event larger than the water quality storm event.

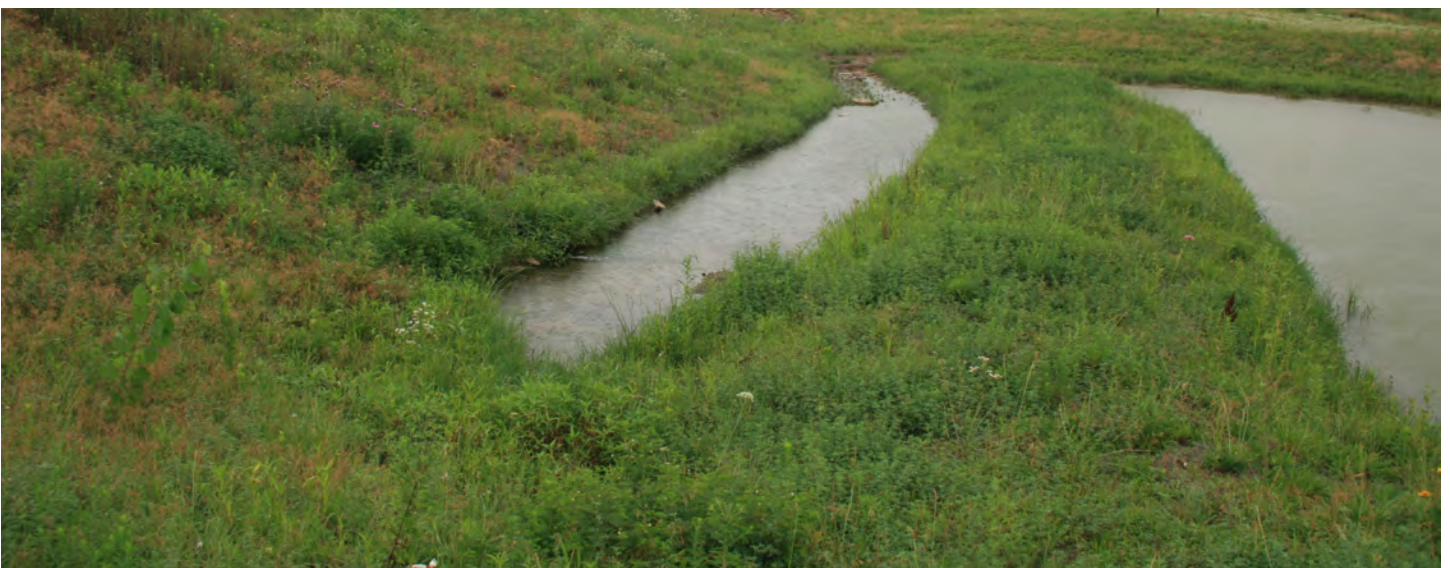
Figure 4.15 Wetland Plants after One Year Establishment

The upland plants started to establish well in the first year. There was not much plant material establishing within the wetland pod shelf zone. The first year, the wetland functioned more like a retention pond than a wetland.

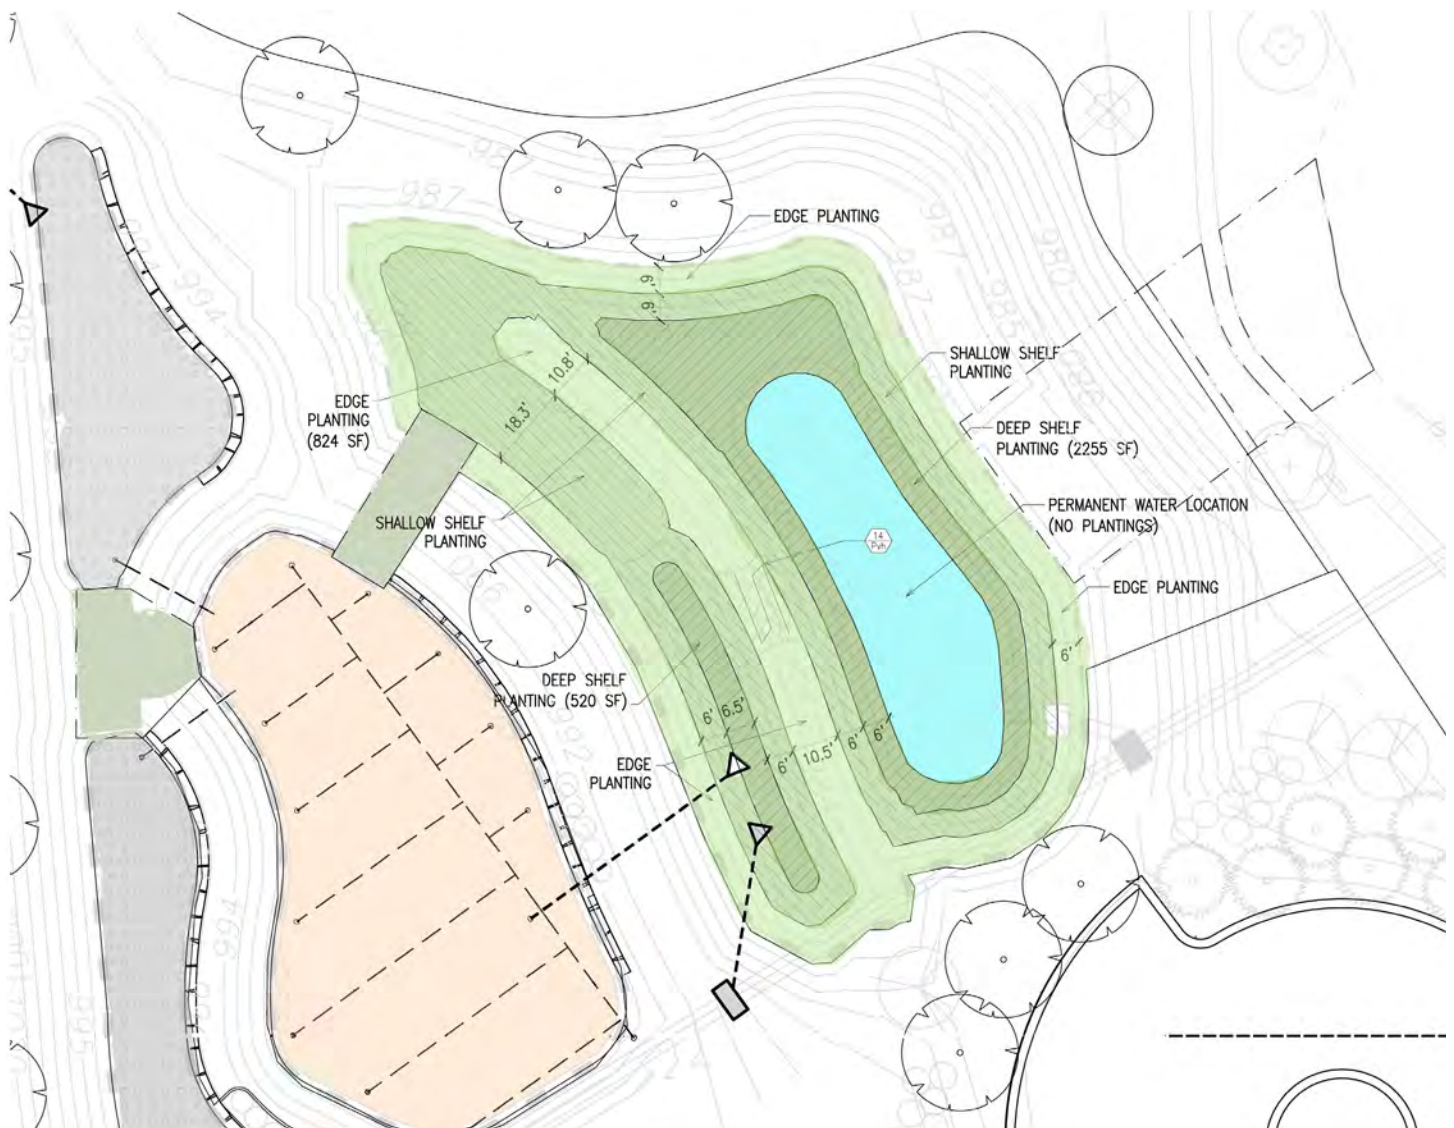
Figure 4.16 Wetland Planting Design Diagram

EDGE PLANTING		SHALLOW SHELF PLANTING		DEEP SHELF PLANTING	
BOTANICAL NAME	COMMON NAME	BOTANICAL NAME	COMMON NAME	BOTANICAL NAME	COMMON NAME
<i>Sorghastrum nutans</i>	Indiangrass	<i>Spartina pectinata</i>	Prairie Cordgrass	<i>Eleocharis palustris</i>	Creeping Spikerush
<i>Panicum virgatum</i>	Switchgrass	<i>Carex vulpinoidea</i>	Fox Sedge	<i>Scirpus fluviatilis</i>	River Bulrush
<i>Rudbeckia triloba</i>	Brown Eyed Susan	<i>Carex hystericina</i>	Bottlebrush Sedge	<i>Scirpus atrovirens</i>	Green Bulrush
<i>Aster novea-angliae</i>	New England Aster	<i>Acorus calamus</i>	Sweet Flag	<i>Scirpus validus</i>	Soft-Stemmed Bulrush
<i>Echinacea purpurea</i>	Purple Coneflower	<i>Iris virginica</i> var. <i>shrevei</i>	Blue Flag Iris	<i>Scirpus fluviatilis</i>	River Bulrush
<i>Echinacea paradoxa</i>	Yellow Coneflower	<i>Alisma subcordatum</i>	Water Plantain	<i>Juncus effusus</i>	Soft Rush
		<i>Asclepias incarnata</i>	Swamp Milkweed	<i>Sagittaria latifolia</i>	Broadleaf Arrowhead

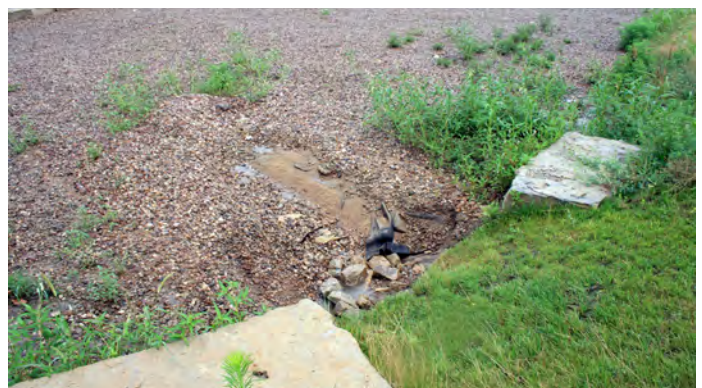
Figure 4.19 Washout at spillway. Weeds visible

- Chemicals: None
- Irrigation: None
- Weeding: Some weeds were pulled near spillway on one occasion during 2010 (See figure 4.19).
- Sedimentation: Some erosion was observed along the northern side of the sand filter. This erosion resulted from the berm along the northern sediment basin failing. The sediment was shoveled off the top of the sand filter within a 100sf area.

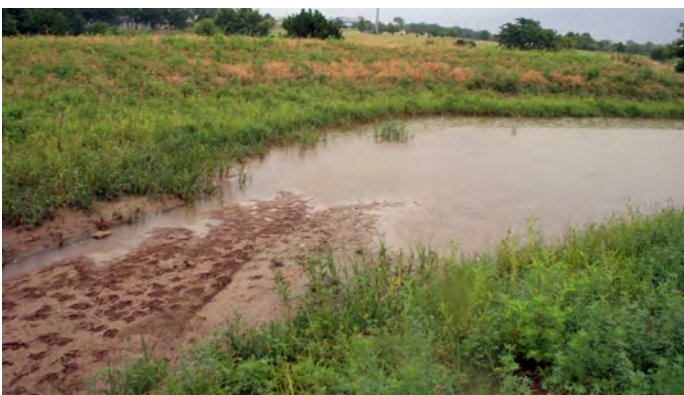
Figure 4.20 Sediment entering wetland

- The wetland seems to be undersized for the site. Large flows will pass through it with minimal residence times, reducing treatment efficiency. Capacity has been further reduced by sedimentation. Correction of upstream erosion problems and dredging the wetland would help improve its performance.

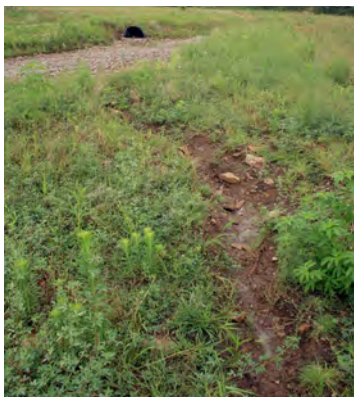
Figure 4.21 Erosion from sediment trap

- Chemicals: None
- Irrigation: None
- Weeding: None
- Erosion: The berm around the northern sediment forebay was compromised in three locations and requires restoration. The elevation of the berm compared to the elevation of the spillway appears to be within 12 inches of the spillway elevation. Combined with the erosive nature of the soils and lack of established vegetation, the berm failed.
- Adjustment: At the northern sediment forebay, the velocity of runoff from the 30" diameter storm pipe displaced the riprap at the pipe outlet requiring hand replacement once during 2010.
- Eventually the sediment forebay will become clogged with sediment and will require cleaning. It was the design team's expectation that the sediment forebay will be successful for approximately 5 to 10 years.

- Size berms and conveyance features of sediment forebays appropriately to hold and convey large rain events without deterioration. The southern forebay berm height of 24-inches taller than the top of the overflow channel was successful. The northern sediment forebay berm height of 12-inches higher than the overflow channel was undersized.
- Evaluate the size of rock at the sediment forebay inlet to reduce erosion potential. Even though the sediment forebay was 3' deep of 6-12 inch diameter rock, larger rock should have been installed at the outlet from the 30" storm sewer pipe.

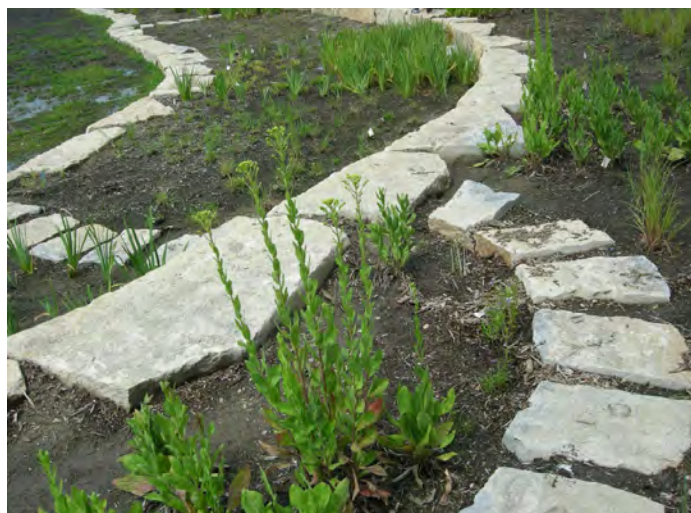
Figure 5.1 Raingarden in 2009

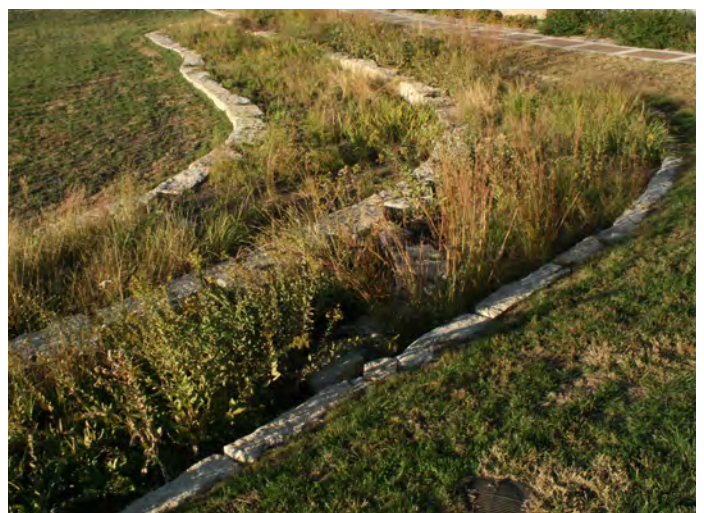
Figure 5.2 Raingarden in Fall 2010

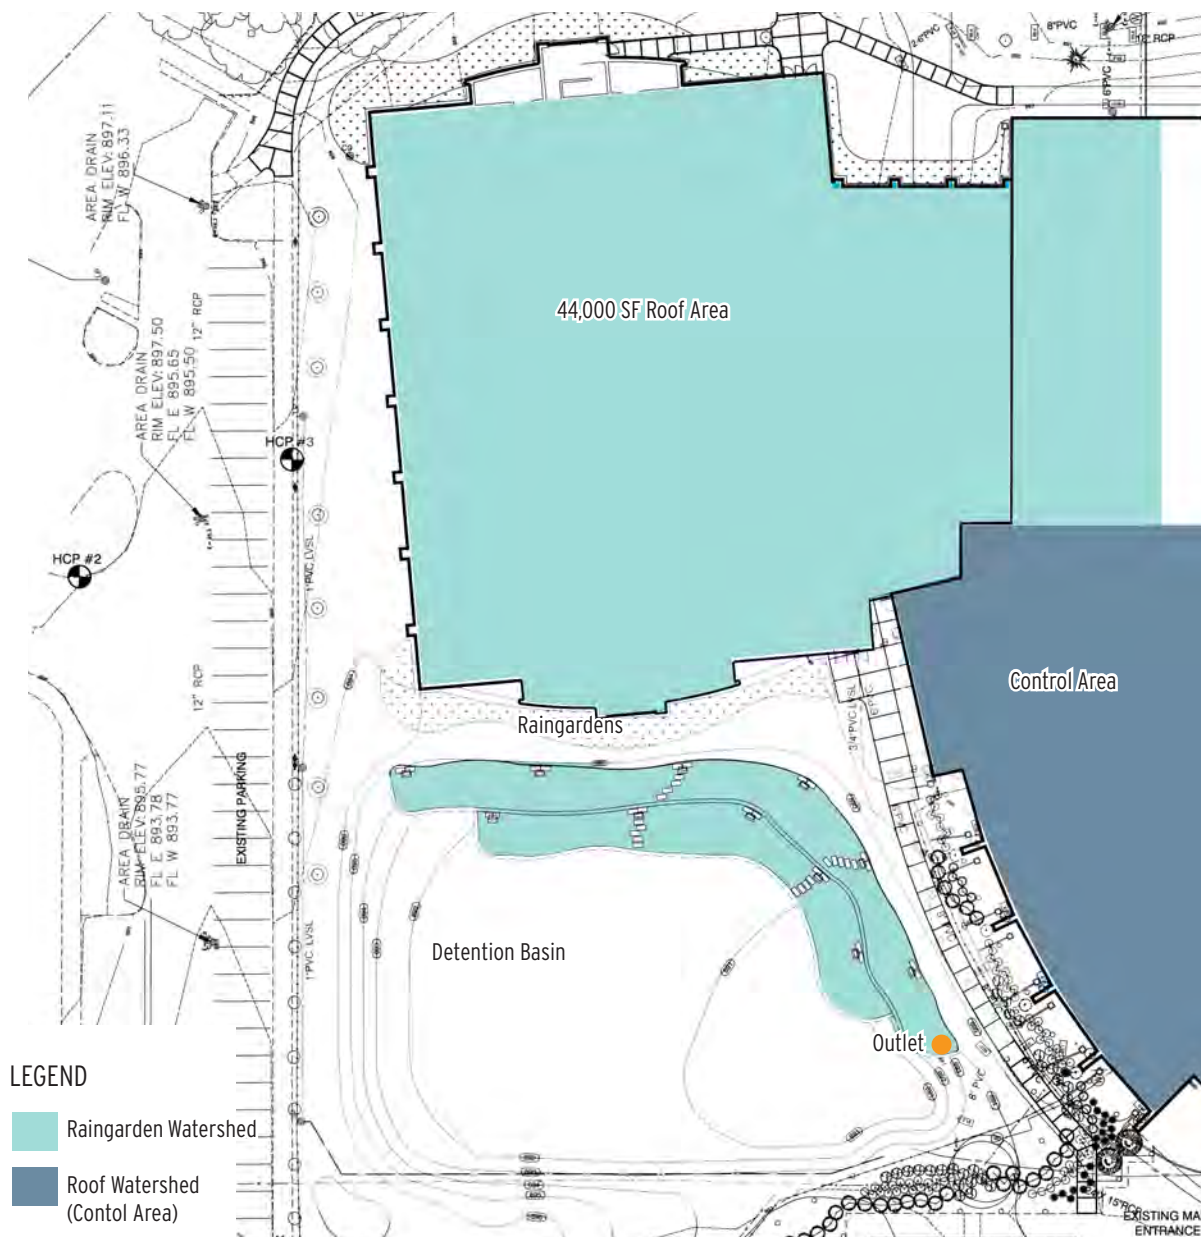
Figure 5.5 Watershed - Building Roof Drainage to Detention basin

Monitoring equipment at the KU site is set up to sample water from two watersheds. The BMP watershed includes water that falls on the roof, and water that falls on and flows through the rain garden and detention basin (Figure 5.5). This system is retrofitted to divert runoff from the building into nine level spreaders that direct runoff into a stepped rain garden and then to an adjacent detention basin. The roof watershed includes only water that falls and the roof. The outlet for both watersheds ties into the storm sewer (Figure 5.6).

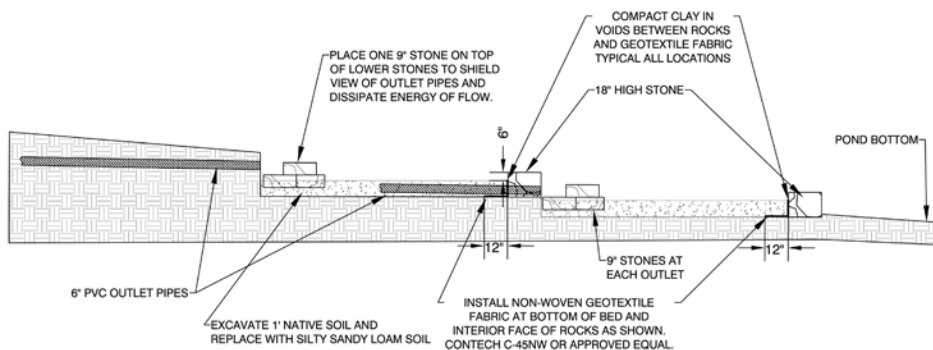
Figure 5.7 Rain garden Section at Pipe Outlets

Figure 5.7 illustrates how water flows through the site to end up at the outlet near the southeast corner of the site. In the BMP watershed, runoff from the roof flows through 8-inch drain pipes into nyloplast manhole structures. These structures are level spreaders which disperses water to eleven (11) outlet points

within the rain garden. To help reduce erosion, stones at each pipe outlet slow water flow. As shown in Figure (5.9), the nine-inch stones buffer views of the outlet pipes, and help dissipate energy of water flow. Dispersing the water over a large area also reduces the possibility of erosion and increases opportunity for infiltration.

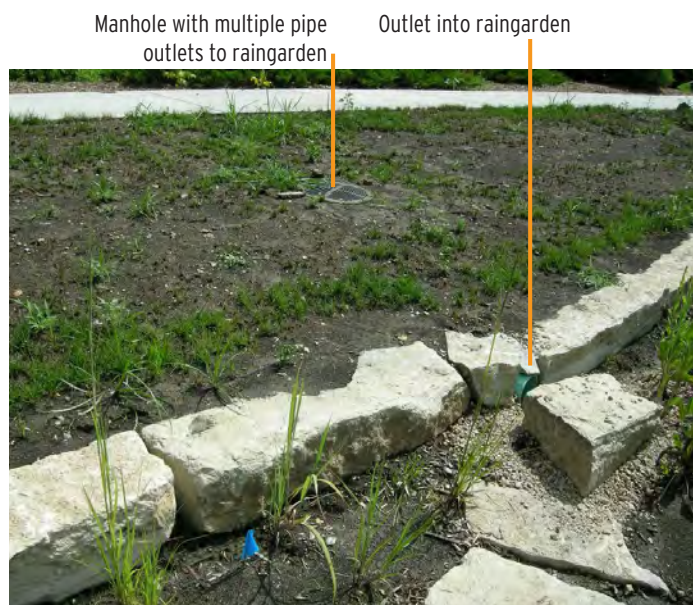
Figure 5.9 Level Spreader Manhole and Outlet (2009)

Figure 5.8 shows the 8-inch drain pipe connecting to the nyloplast manhole structure [level spreader]. The manhole disperses runoff into four separate 6-inch PVC pipes towards different locations within the raingarden. Figure 5.9 and 5.10 show the system successfully installed.

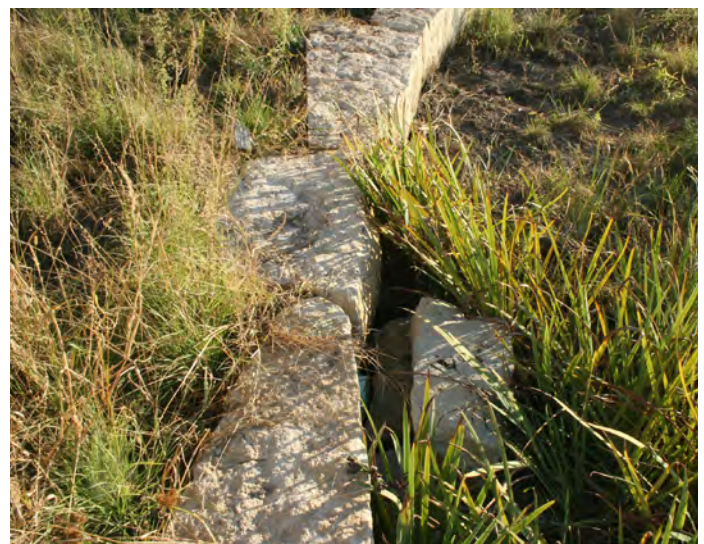
Figure 5.10 Level Spreader Outlet (2010)

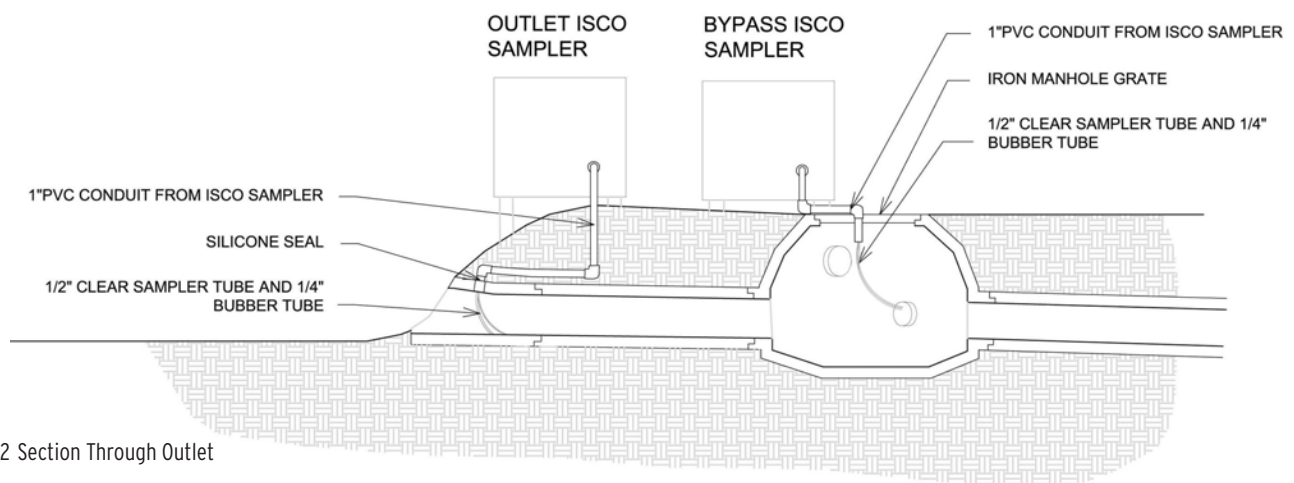
shows how the ISCO monitoring stations are attached to the outlet to obtain the necessary water samples (Figure 5.12). The Tipping Bucket shown in Figure 5.11 is a rain gauge that automatically records rainfall data, rates, times, and duration.

Figure 5.12 Section Through Outlet

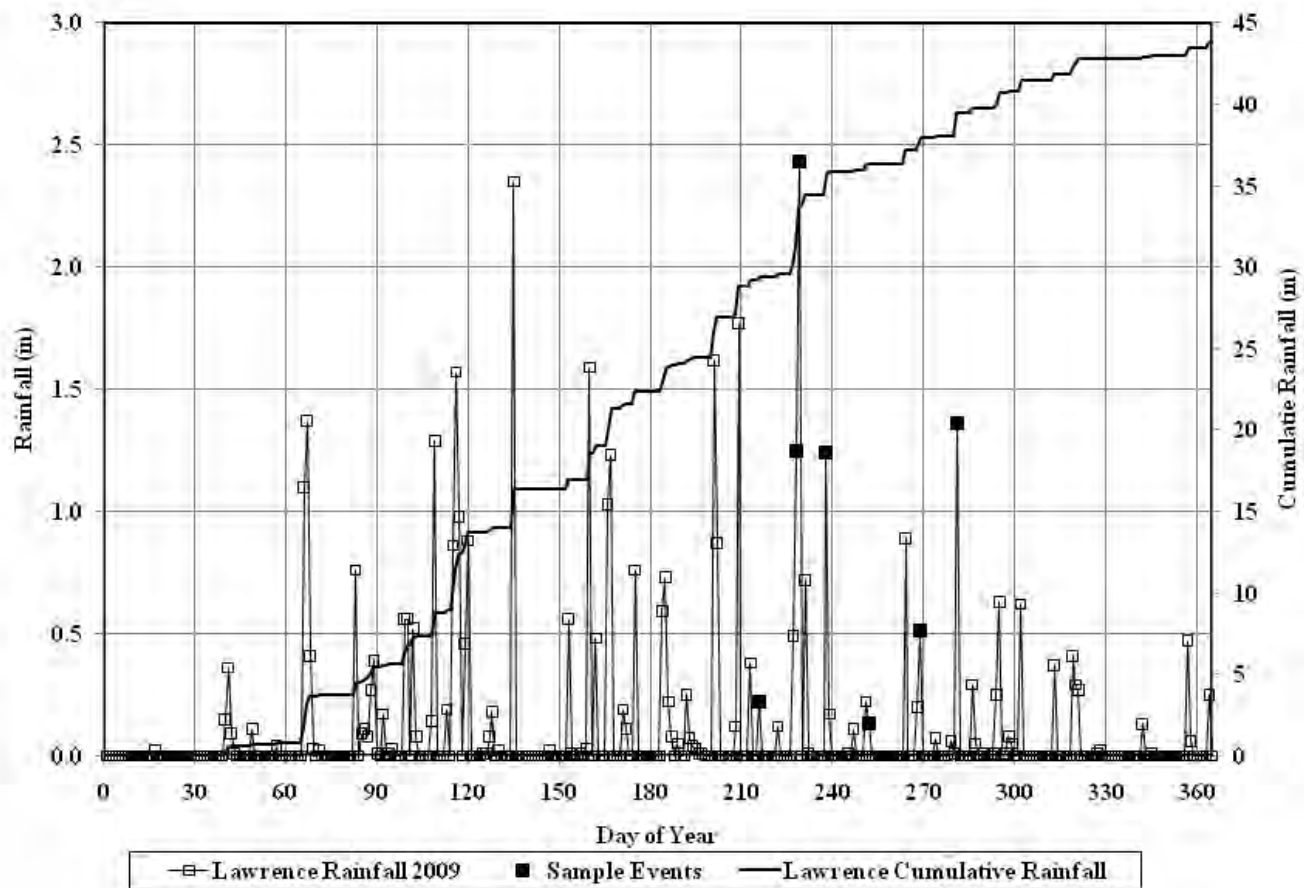
Figure 5.13 Precipitation Summary (2009)

Daily rainfall events and the cumulative rainfall recorded at the Lawrence, Kansas site are shown in Figure 5-45. Rainfall events during which samples were collected are highlighted.

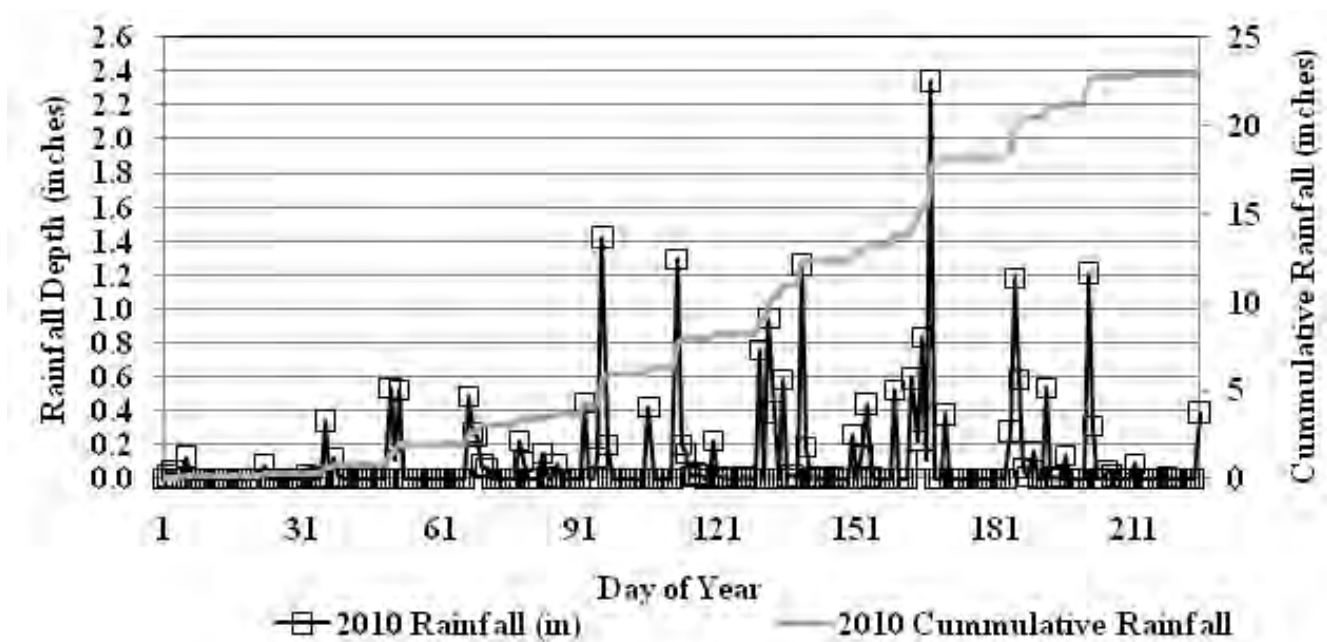
Figure 5.14 Precipitation Summary (2010)

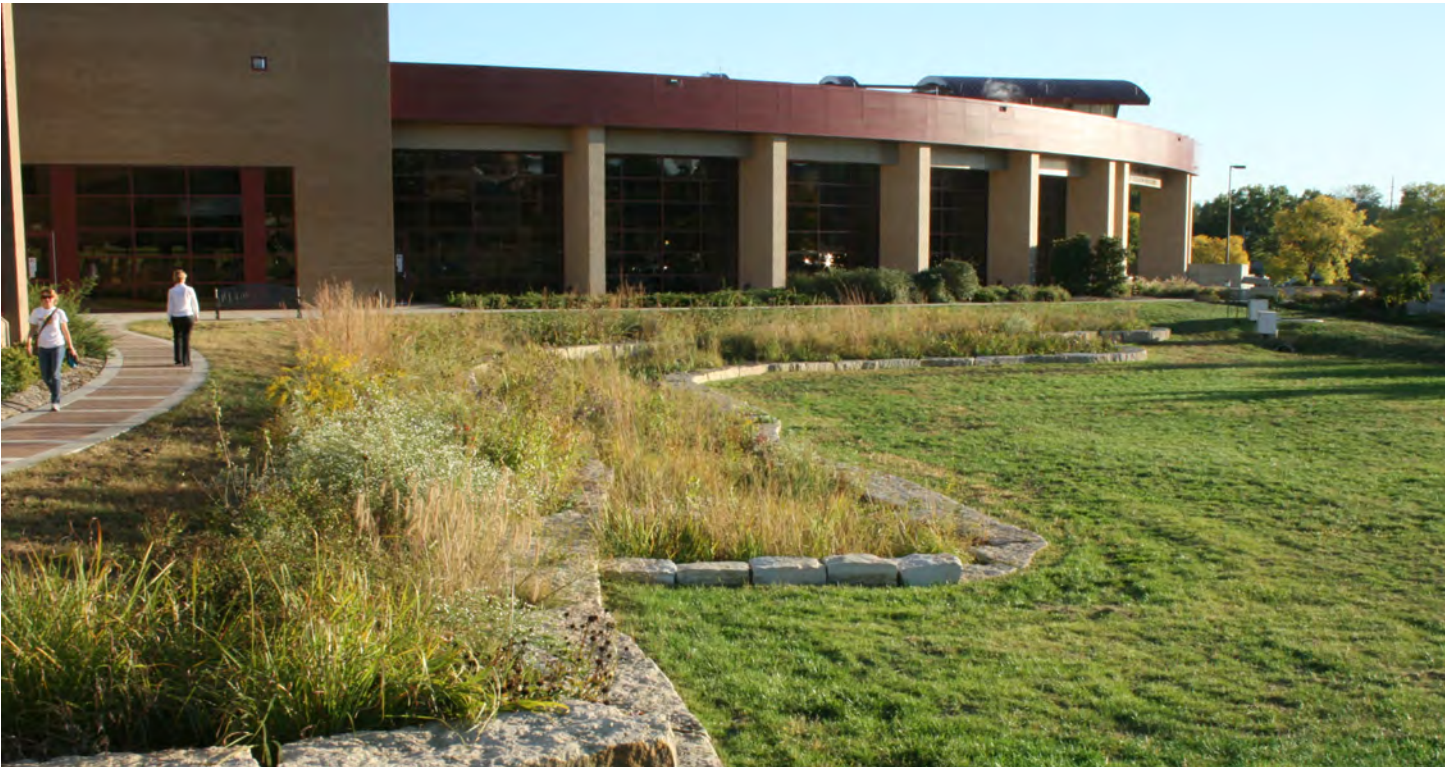
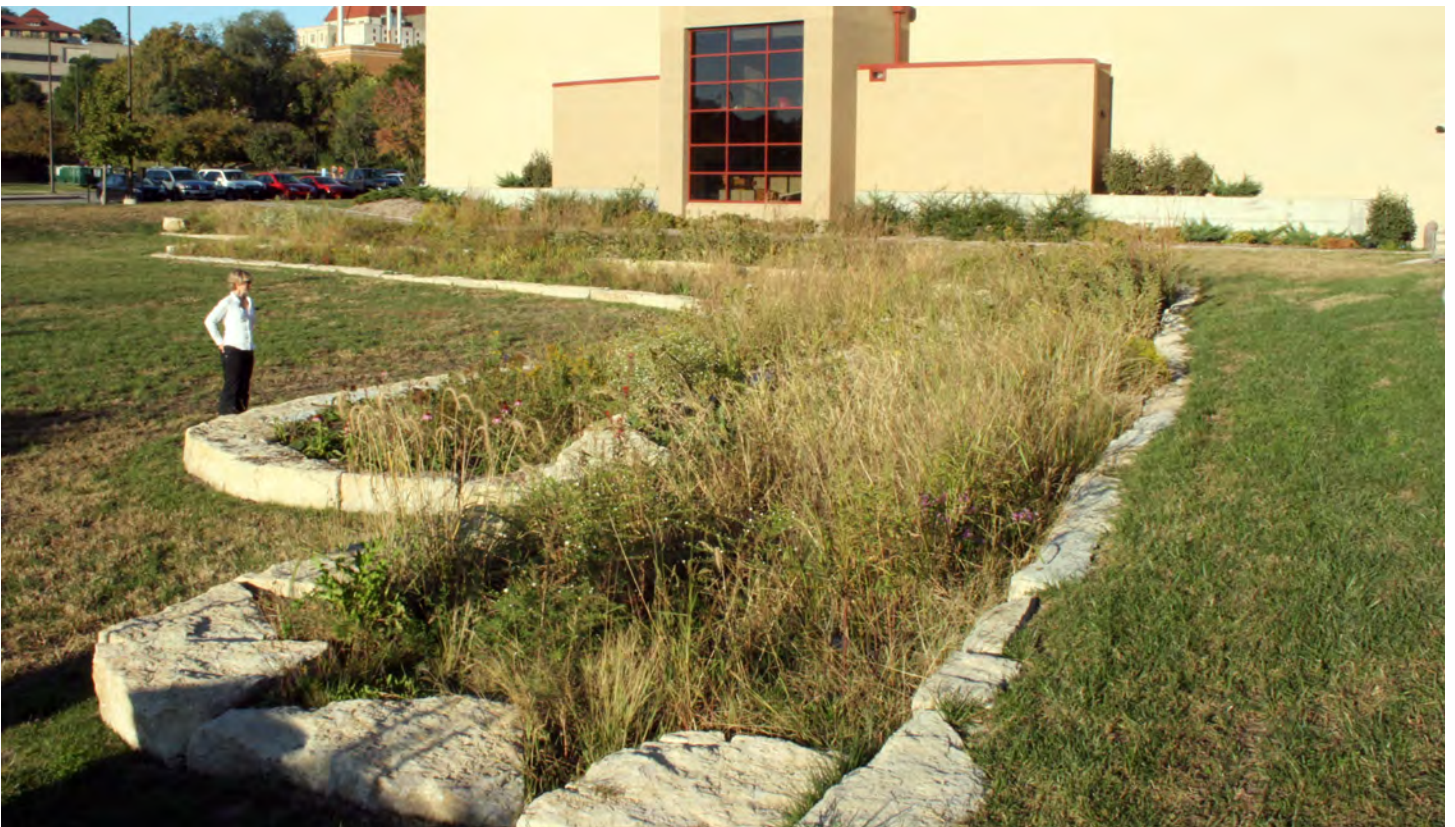
Figure 5.17 Planting (Fall 2010)

The 5,200-square-foot rain garden has 18 native species planted on two terraces bounded by large cut stone. The native plant species were chosen for their adaptability to the site. The vegetation was planted in 2009. After two growing seasons, the plants are well established. These plants have a deeper root depth when compared to the fescue planted detention, which suggests they will help improve infiltration over time as their root systems continue to expand.

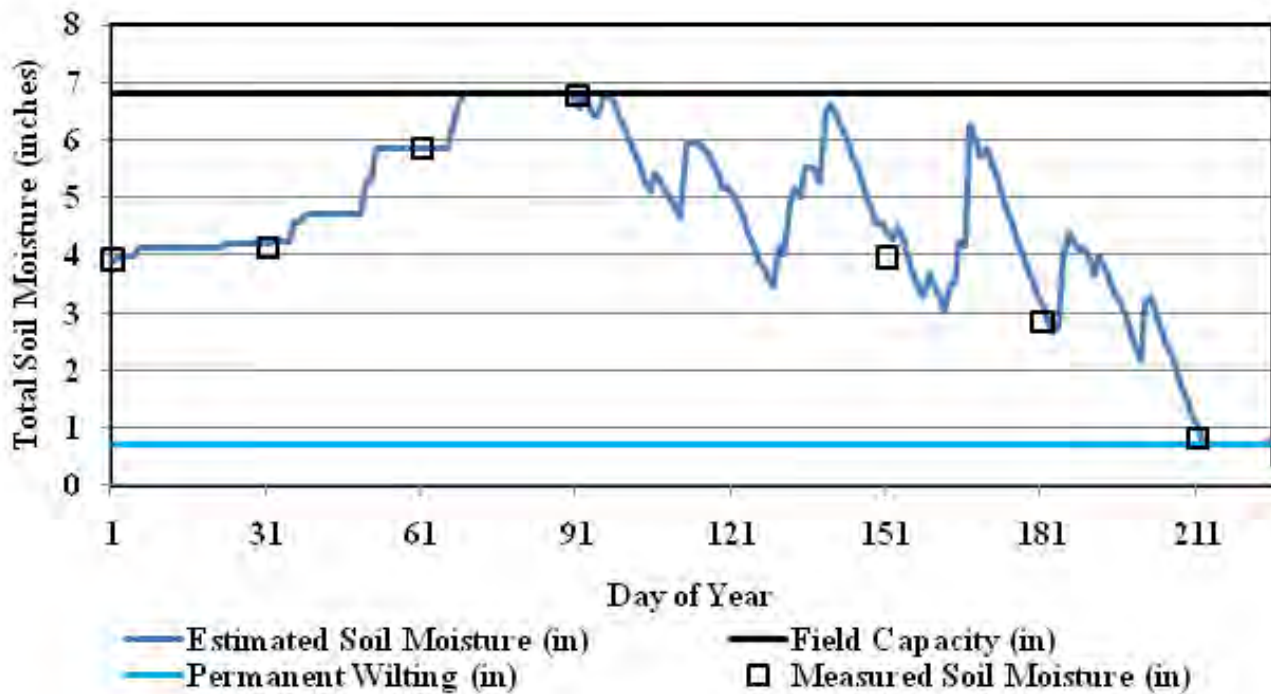
The following figure shows the soil moisture within the raingarden. A soil core was taken for the entire 12-inch depth of engineered soil. A moisture test was conducted approximately monthly (as shown by the black boxes). The black horizontal line represents soil moisture at 1/3 bar (not quite full saturation). The blue line represents the results from the Modified Penman Equation. This equation estimates the amount of water available for grasses. The equation takes into account components of evapotranspiration. As the blue line nears the 1/3 bar, the basin is considered saturated and runoff is expected. Overflows out of the raingarden were expected from about day 61 (March 1st) through about day 171 (June 20th).

Figure 5.18 Soil Moisture (2010)

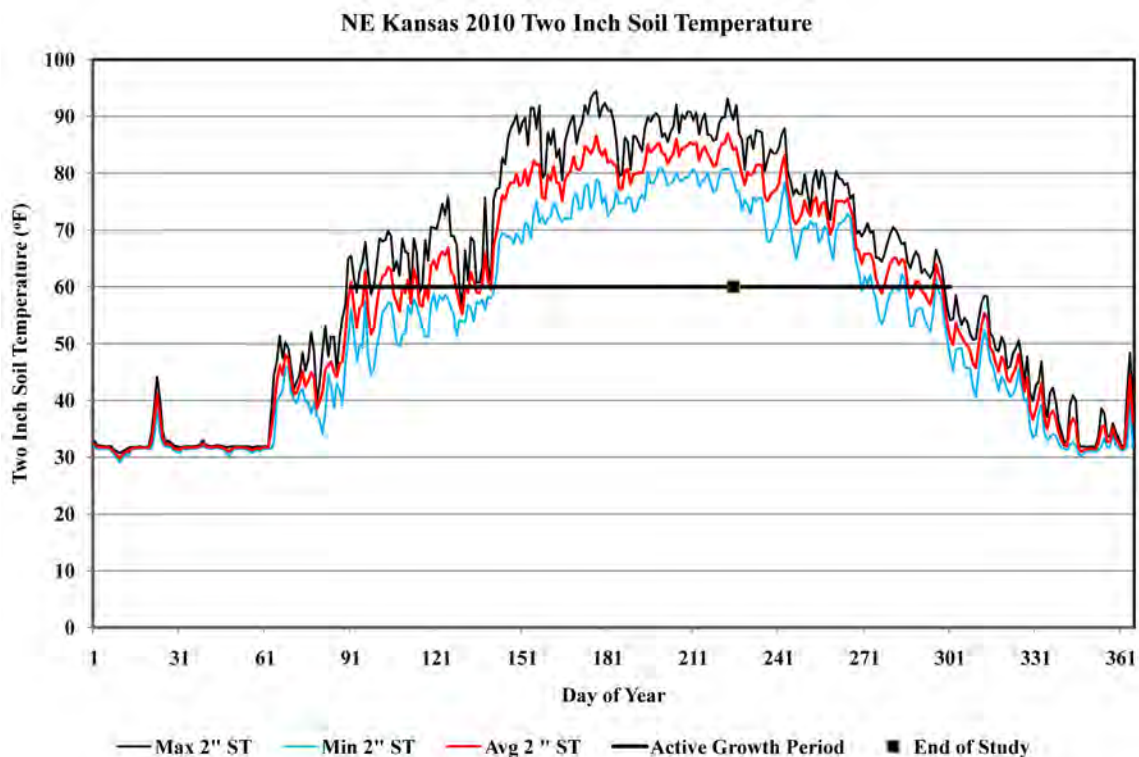
The following figure shows the soil temperature as monitored in northeast Kansas (about 90 minutes from the Kansas City metropolitan area). The below soil moisture was measured at a depth of two inches. Around day 91 (April 1st) the soil temperatures rise to 60 degrees and warm season plants start to grow.

Figure 7.1 2010 NE Kansas Soil Temperature

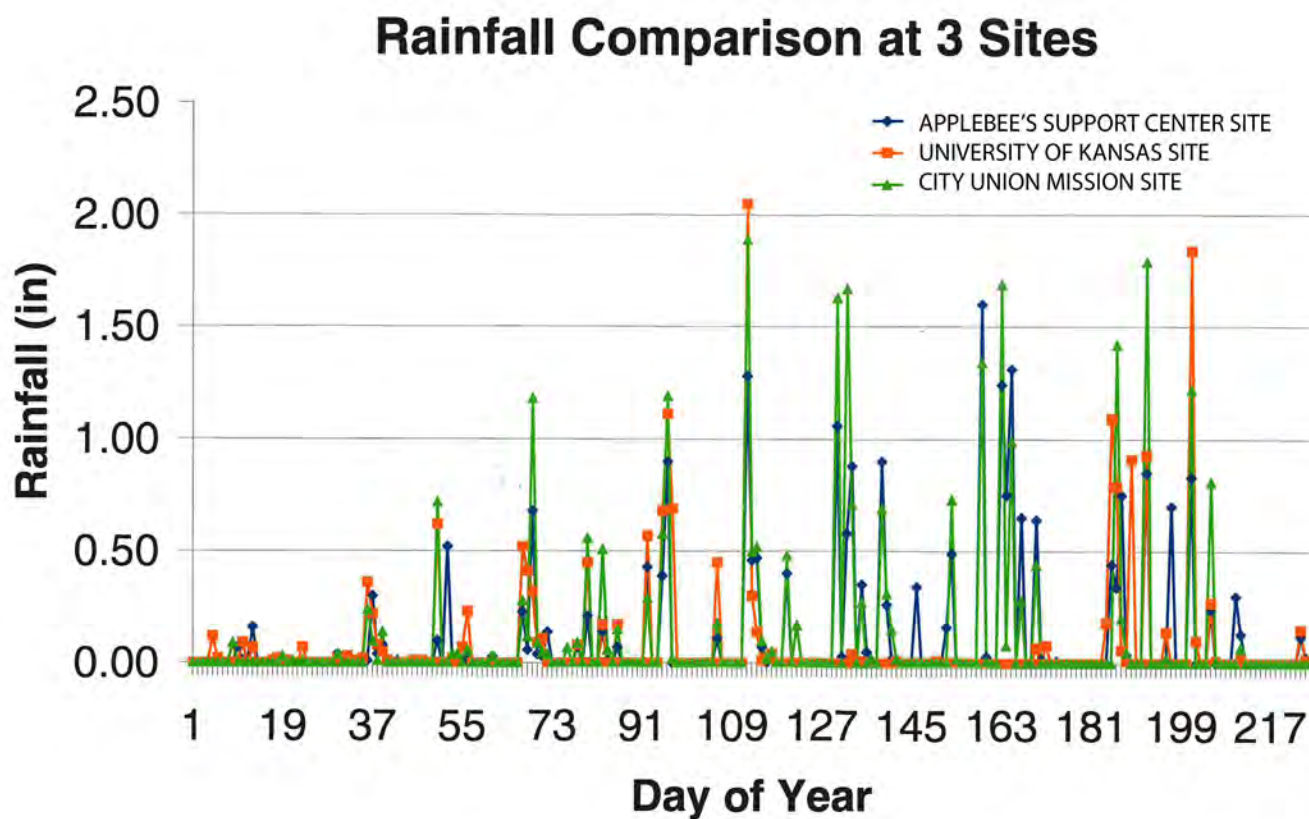
Figure 7.2 Comparison of Rain Events at Three Sites

This shows a comparison of the rain events occurring in 2010 from the different sites. All of the sites are within a 50 minute drive of each other. The chart illustrates how rainfall intensities can vary across even small areas during common storm events.
